DEPARTMENT OF TRANSPORTATION

Contract #: 04-0120F4Cty: SF/ALA Rte: 80 PM: 13.2/13.9File #: 70.28**WELDING INSPECTION REPORT****Resident Engineer:** Pursell, Gary**Address:** 333 Burma Road**City:** Oakland, CA 94607**Report No:** WIR-003297**Date Inspected:** 25-Jul-2008**Project Name:** SAS Superstructure**OSM Arrival Time:** 2300**Prime Contractor:** American Bridge/Fluor Enterprises, a JV**OSM Departure Time:** 700**Contractor:** Japan Steel Works**Location:** Muroran, Japan**CWI Name:** Makhmud Ashadi**CWI Present:** Yes No**Inspected CWI report:** Yes No N/A**Rod Oven in Use:** Yes No N/A**Electrode to specification:** Yes No N/A**Weld Procedures Followed:** Yes No N/A**Qualified Welders:** Yes No N/A**Verified Joint Fit-up:** Yes No N/A**Approved Drawings:** Yes No N/A**Approved WPS:** Yes No N/A**Delayed / Cancelled:** Yes No N/A**Bridge No:** 34-0006**Component:** Tower, Deviation and Jacking Saddles**Summary of Items Observed:**

WELDING INSPECTION REPORT

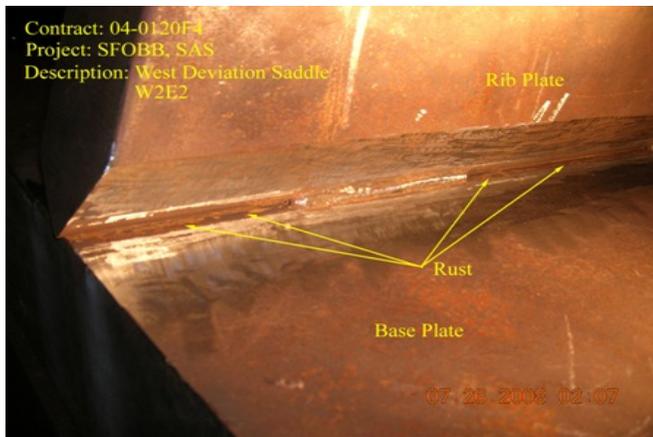
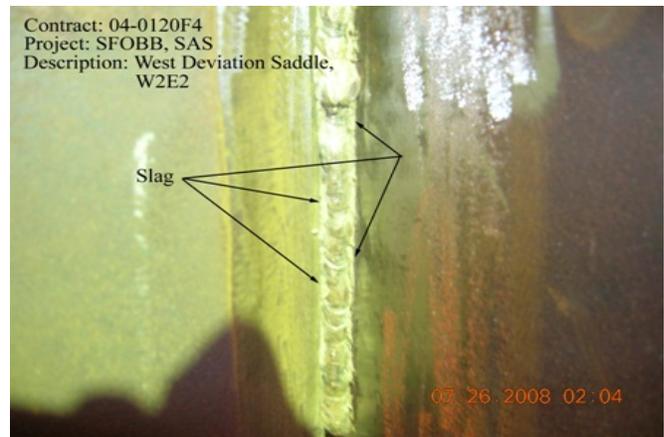
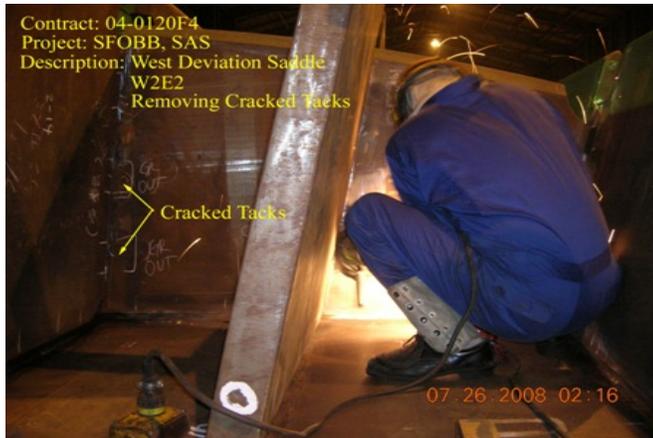
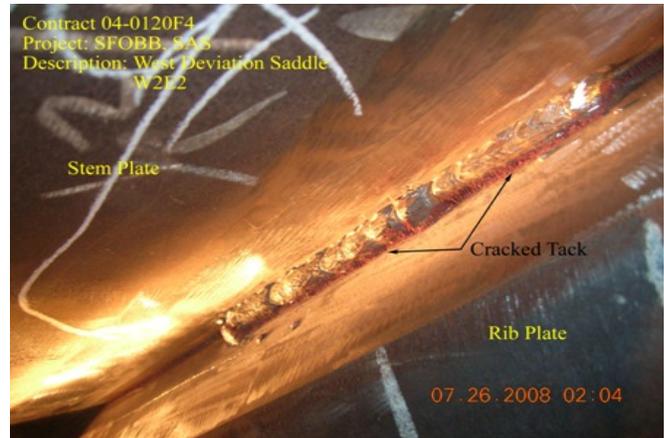
The QA inspector traveled to the Fabrication Shop # 4 to observe the work scheduled for the C-Shift. Upon the QA inspector's arrival at the shop facility it was noted that the West Deviation Saddle identified as W2E2 had been mobilized from Lane A to Lane B and set in the positioner located between column lines B3 and B4. Shortly thereafter, the QA inspector observed the Quality Control (QC) Inspector, Intertek Testing Service personnel Makhmud Ashadi performing a visual weld inspection of the tack welds at the stem plate to rib and base plate connections and the rib plate to base plate connections. The QC inspection revealed twenty (20) cracked tacks which appeared to be isolated at the rib to stem plate connection. The cracks appeared to be located along the fusion zone at the toe of the weld on the rib plate side for the following weld joints identified as E2Y-5V, E2Y-7V, E2Y-9V, E2Y-12V, E2Y-14V, E2Y-15V and E2Y-16V. For additional information see Summary of Conversations.

Later in the shift the QA inspector observed that the Japan Steel Works, Ltd. (JSW) personnel had commenced the removal of the cracked tacks utilizing grinding tools.

At the conclusion of the QA inspector verifying the locations of the cracked tacks it was also noted that there were a number of the tack welds that will require the removal of slag located at the toe of the tack weld prior to Visual Inspection (VT) and Magnetic Particle Testing (MPT). It was also noted that there appears to be rust in the Partial Joint Penetration (PJP) groove weld that will require removal prior to the continued tack welding of the PJP groove weld. The QA inspector informed the QC inspector of these issues and at the conclusion of review of the areas in question the QC inspector concurred with the QA inspector's assessment. The QC inspector, Mr. Ashadi also informed the QA inspector that the dayshift QC inspector, ITS personnel Chung Fu-Kuan would also be notified of these issues.
