DEPARTMENT OF TRANSPORTATION

Office of Structural Materials

Contract #: 04-0120F4Cty: SF/ALA Rte: 80 PM: 13.2/13.9File #: 69.28**WELDING INSPECTION REPORT****Resident Engineer:** Pursell, Gary**Address:** 333 Burma Road**City:** Oakland, CA 94607**Report No:** WIR-003340**Date Inspected:** 17-Jul-2008**Project Name:** SAS Superstructure**OSM Arrival Time:** 700**Prime Contractor:** American Bridge/Fluor Enterprises, a JV**OSM Departure Time:** 1500**Contractor:** Zhenhua Port Machinery Company, Ltd (ZPMC), Changxing Island **Location:** Shanghai, China**CWI Name:** Sun Wei**CWI Present:** Yes No**Inspected CWI report:** Yes No N/A**Rod Oven in Use:** Yes No N/A**Electrode to specification:** Yes No N/A**Weld Procedures Followed:** Yes No N/A**Qualified Welders:** Yes No N/A**Verified Joint Fit-up:** Yes No N/A**Approved Drawings:** Yes No N/A**Approved WPS:** Yes No N/A**Delayed / Cancelled:** Yes No N/A**Bridge No:** 34-0006**Component:** OBG**Summary of Items Observed:**

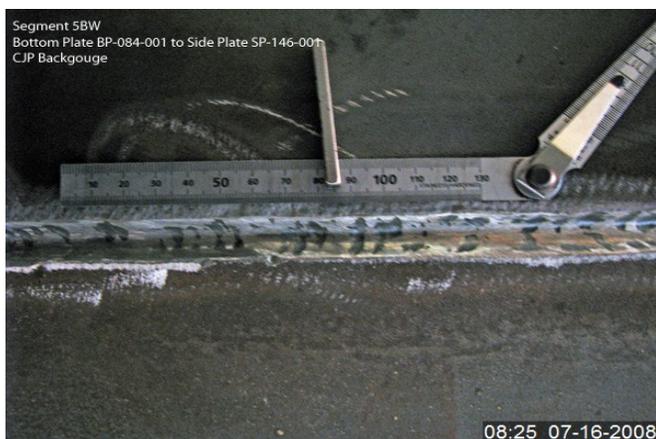
Segment 5BW – The Quality Assurance Inspector witnessed two ZPMC welding operators performing in process welding of Side Panel SP-146-001 to Bottom Panel BP-084-001. The welders were utilizing the shielded metal arc welding process to produce the complete joint penetration weld in the overhead position. QA observed the lack of grinding that took place prior to welding of the back gouged excavation. The back gouged excavation was performed by the air carbon arc process. AWS D1.5 2002 section 3.2.6 states “Where any carbon arc gouging or cutting is involved, proper arc gouging procedures shall be used to avoid the retention of carbon deposits and material or dross in the areas which are to be welded. Air carbon arc gouged surfaces shall be ground to bright metal. The Quality Assurance Inspector generated an incident pertaining to the discrepancy. Below is a digital photograph illustrating the discrepancy.

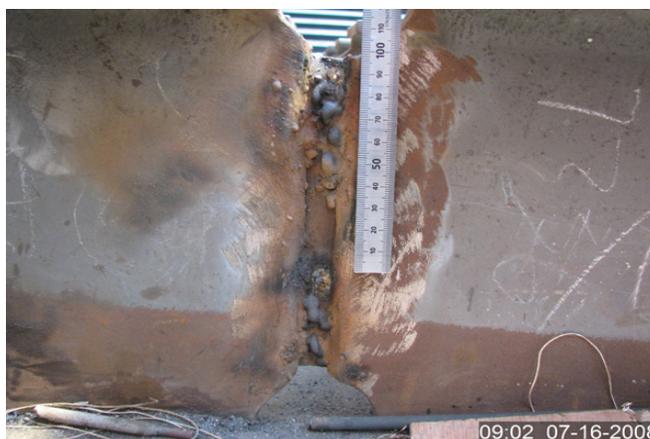
The Quality Assurance Inspector witnessed where ZPMC added metal backing to the web splice of nine Side Panels identified as SP-019-001. ZPMC QC relayed the addition was due to excessive root openings. The backing was tacked to the parts within the groove in a substandard manor as illustrated in the digital photograph below. ZPMC added the backing would be removed and the joints would be back gouged.
