DEPARTMENT OF TRANSPORTATION

Contract #: 04-0120F4Cty: SF/ALA Rte: 80 PM: 13.2/13.9File #: 69.28**WELDING INSPECTION REPORT****Resident Engineer:** Pursell, Gary**Address:** 333 Burma Road**City:** Oakland, CA 94607**Report No:** WIR-003437**Date Inspected:** 31-Jul-2008**Project Name:** SAS Superstructure**OSM Arrival Time:** 1400**Prime Contractor:** American Bridge/Fluor Enterprises, a JV**OSM Departure Time:** 2230**Contractor:** Zhenhua Port Machinery Company, Ltd (ZPMC), Changxing Island **Location:** Shanghai, China**CWI Name:** Huang Wen Pang**CWI Present:** Yes No**Inspected CWI report:** Yes No N/A**Rod Oven in Use:** Yes No N/A**Electrode to specification:** Yes No N/A**Weld Procedures Followed:** Yes No N/A**Qualified Welders:** Yes No N/A**Verified Joint Fit-up:** Yes No N/A**Approved Drawings:** Yes No N/A**Approved WPS:** Yes No N/A**Delayed / Cancelled:** Yes No N/A**Bridge No:** 34-0006**Component:** OBG**Summary of Items Observed:**

Sub Assembly Bay # 1 (OBG)

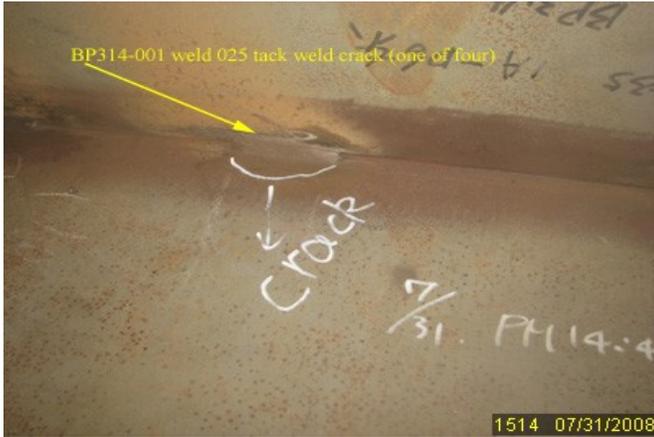
QA was informed by ZPMC Quality Control Huang Wen Pang that 4 tack welds on Bottom Plate BP314-001 weld 025 were cracked. QA observed Tack weld cracks ranging from 15 to 80 mm in length. Areas of cracking were excavated and Magnetic Particle Testing performed. QA witnessed ZPMC QC test and accept weld excavations. Please see the attached photo below of tack weld cracks prior to excavation.
