DEPARTMENT OF TRANSPORTATION

Quality Assurance and Source Inspection

Contract #: 04-0120F4Cty: SF/ALA Rte: 80 PM: 13.2/13.9File #: 69.28**WELDING INSPECTION REPORT****Resident Engineer:** Pursell, Gary**Address:** 333 Burma Road**City:** Oakland, CA 94607**Report No:** WIR-003444**Date Inspected:** 12-Jul-2008**Project Name:** SAS Superstructure**OSM Arrival Time:** 700**Prime Contractor:** American Bridge/Fluor Enterprises, a JV**OSM Departure Time:** 1530**Contractor:** Zhenhua Port Machinery Company, Ltd (ZPMC), Changxing Island **Location:** Shanghai, China**CWI Name:** See Below**CWI Present:** Yes No**Inspected CWI report:** Yes No N/A**Rod Oven in Use:** Yes No N/A**Electrode to specification:** Yes No N/A**Weld Procedures Followed:** Yes No N/A**Qualified Welders:** Yes No N/A**Verified Joint Fit-up:** Yes No N/A**Approved Drawings:** Yes No N/A**Approved WPS:** Yes No N/A**Delayed / Cancelled:** Yes No N/A**Bridge No:** 34-0006**Component:** Tower & OBG**Summary of Items Observed:**

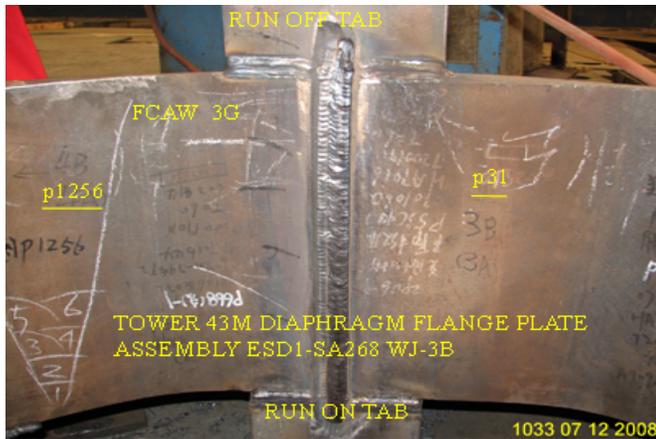
The QA Inspector randomly observed ZPMC welder Li Zhao Qian ID Number 048810, utilizing the Flux Cored Arc Welding (FCAW) Process in the 3G (Vertical Groove) Position with ZPMC Weld Procedure Specification (WPS) WPS-B-T-2233-B-U3-F, to weld the butt splice between 43M Bottom Diaphragm Flange Plate Assembly ESD1-SA268 sections p31 and p1256 at WJ ESD1-SA268-3B. The QA Inspector randomly observed ZPMC CWI Zhao Chen Sun monitoring weld parameters. The QA Inspector also randomly monitored weld parameters and recorded them as follows: 216 amps, 26.4 volts with a travel speed of 116 millimeters (mm) per minute. The weld parameters appeared to comply with contract requirements. The attached photograph provides additional detail.

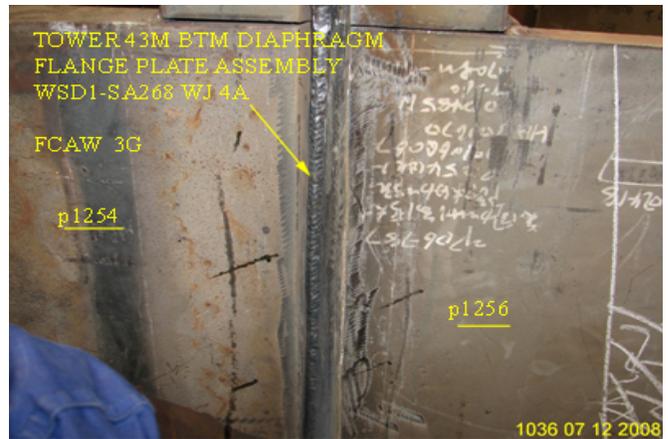
The QA Inspector randomly observed ZPMC welder Li Mengqian ID Number 054460, utilizing the FCAW Process in the 3G (Vertical Groove) Position with ZPMC WPS WPS-B-T-2233-B-U3-F, to weld the butt splice between 43M Bottom Diaphragm Flange Plate Assembly WSD1-SA268 sections p1254 and p1256 at WJ WSD1-SA268-4A. The QA Inspector randomly observed ZPMC QC monitoring weld parameters. The QA Inspector also randomly monitored weld parameters and recorded them as follows: 213 amps, 26 volts with a travel speed of 115 mm per minute. The weld parameters appeared to comply with contract requirements. The attached photograph provides additional detail.

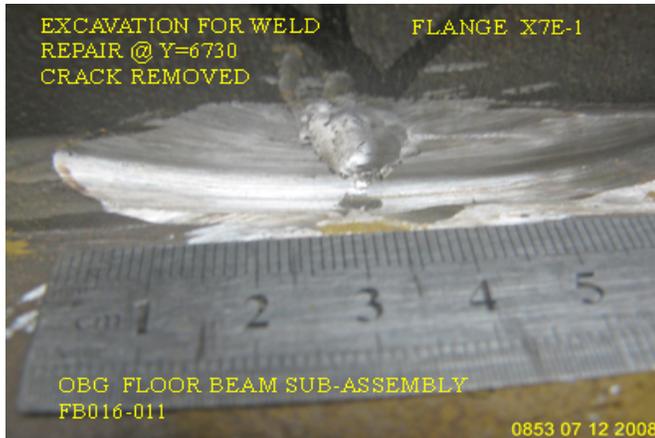
The QA Inspector randomly observed ZPMC Non Destructive Testing (NDT) Technician Bo Ti Rui, utilizing the Magnetic Particle Testing (MT) Method to examine excavations in WJ's 003 and 009 on Floor Beam Sub-Assembly FB016-011 in accordance with ZPMC Critical Weld Repair Procedure (CWR) B-CWR121. The excavations had been performed to remove transverse cracks at locations Y=6730 and 2670 in WJ 003 and Y=2001 and 2450 in WJ 009. There were a total of 5 transverse cracks removed from the 4 excavations. The referenced ZPMC MT Report is B787-MT-1786. There appeared to be no indications and ZPMC QC released the excavations for weld repair. The following photograph provides additional detail.
