DEPARTMENT OF TRANSPORTATION

Contract #: 04-0120F4Cty: SF/ALA Rte: 80 PM: 13.2/13.9File #: 69.28**WELDING INSPECTION REPORT****Resident Engineer:** Pursell, Gary**Address:** 333 Burma Road**City:** Oakland, CA 94607**Report No:** WIR-003474**Date Inspected:** 05-Aug-2008**Project Name:** SAS Superstructure**OSM Arrival Time:** 630**Prime Contractor:** American Bridge/Fluor Enterprises, a JV**OSM Departure Time:** 1530**Contractor:** Zhenhua Port Machinery Company, Ltd (ZPMC), Changxing Island **Location:** Shanghai, China**CWI Name:** Wu Zhi Feng and Zhashi**CWI Present:** Yes No**Inspected CWI report:** Yes No N/A**Rod Oven in Use:** Yes No N/A**Electrode to specification:** Yes No N/A**Weld Procedures Followed:** Yes No N/A**Qualified Welders:** Yes No N/A**Verified Joint Fit-up:** Yes No N/A**Approved Drawings:** Yes No N/A**Approved WPS:** Yes No N/A**Delayed / Cancelled:** Yes No N/A**Bridge No:** 34-0006**Component:** OBG and SAS Tower Fabrication**Summary of Items Observed:**

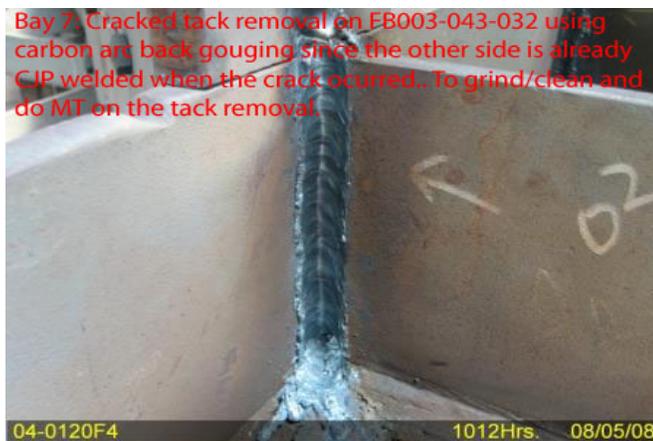
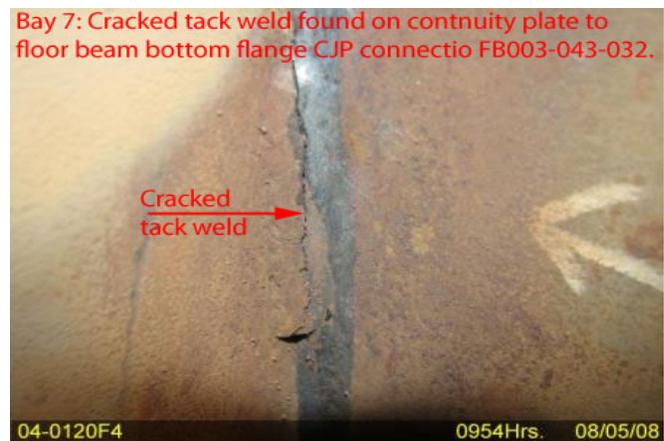
ZPMC/QC has noted one tack weld that has crack on continuity plate to floor beam bottom flange FB003-043-032.

This QA has verified the existence of the crack and ZPMC used carbon arc gouging to remove the cracked tack weld since it is at the other side of CJP weld. This QA also witness the tack removal thru carbon arc gouging but not the MT of the removal since it was done during the other work shift. See photo below.
