DEPARTMENT OF TRANSPORTATION

Quality Assurance and Source Inspection

Contract #: 04-0120F4Cty: SF/ALA Rte: 80 PM: 13.2/13.9File #: 69.28**WELDING INSPECTION REPORT****Resident Engineer:** Pursell, Gary**Address:** 333 Burma Road**City:** Oakland, CA 94607**Report No:** WIR-003478**Date Inspected:** 21-Jul-2008**Project Name:** SAS Superstructure**OSM Arrival Time:** 1400**Prime Contractor:** American Bridge/Fluor Enterprises, a JV**OSM Departure Time:** 2200**Contractor:** Zhenhua Port Machinery Company, Ltd (ZPMC), Changxing Island **Location:** Shanghai, China**CWI Name:** Huang Wen Pang**CWI Present:** Yes No**Inspected CWI report:** Yes No N/A**Rod Oven in Use:** Yes No N/A**Electrode to specification:** Yes No N/A**Weld Procedures Followed:** Yes No N/A**Qualified Welders:** Yes No N/A**Verified Joint Fit-up:** Yes No N/A**Approved Drawings:** Yes No N/A**Approved WPS:** Yes No N/A**Delayed / Cancelled:** Yes No N/A**Bridge No:** 34-0006**Component:** skin plate, rib to bottom plate weld**Summary of Items Observed:**

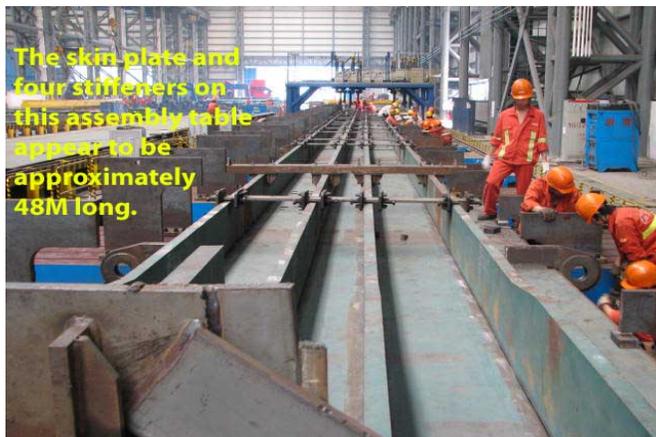
QA Inspector randomly observed one very large skin plate on a raised assembly table with four skin stiffener fit-up and tacked and held in place with mechanical and hydraulic alignment devices. See photo below of the skin plate and four stiffeners on assembly table.

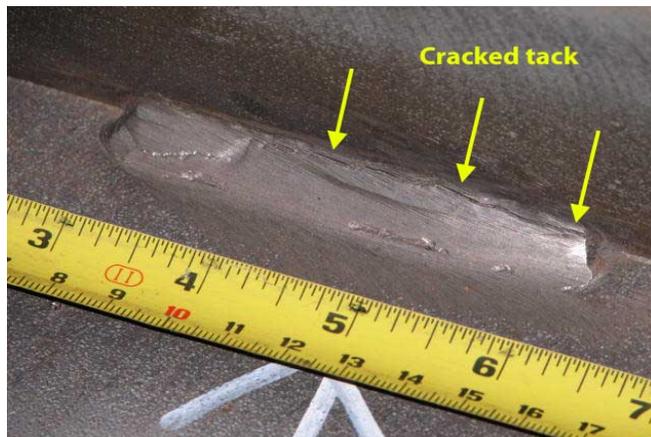
QA Inspector observed the grinding out and removal of a cracked tack weld at BP306-001-08. See photo below of cracked tack before grinding. QA Inspector observed ZPMC MT operator perform MT on the ground out tack and

report to QA Inspector that no indications were observed. QA Inspector concurred. Also present and observing the operation was ZPMC CWI Huang Wen Pang who also concurred with no observance of an indication. Approximately 60 ZPMC workers were present in the bay.
