DEPARTMENT OF TRANSPORTATION

Contract #: 04-0120F4Cty: SF/ALA Rte: 80 PM: 13.2/13.9File #: 69.28**WELDING INSPECTION REPORT****Resident Engineer:** Pursell, Gary**Address:** 333 Burma Road**City:** Oakland, CA 94607**Report No:** WIR-003485**Date Inspected:** 16-Jul-2008**Project Name:** SAS Superstructure**OSM Arrival Time:** 1400**Prime Contractor:** American Bridge/Fluor Enterprises, a JV**OSM Departure Time:** 2200**Contractor:** Zhenhua Port Machinery Company, Ltd (ZPMC), Changxing Island **Location:** Shanghai China**CWI Name:** Zhu Zhong Hai**CWI Present:** Yes No**Inspected CWI report:** Yes No N/A**Rod Oven in Use:** Yes No N/A**Electrode to specification:** Yes No N/A**Weld Procedures Followed:** Yes No N/A**Qualified Welders:** Yes No N/A**Verified Joint Fit-up:** Yes No N/A**Approved Drawings:** Yes No N/A**Approved WPS:** Yes No N/A**Delayed / Cancelled:** Yes No N/A**Bridge No:** 34-0006**Component:** Tower**Summary of Items Observed:**

89m mock up

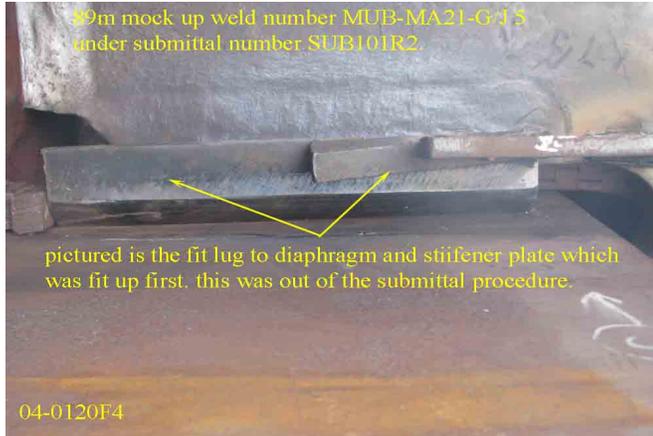
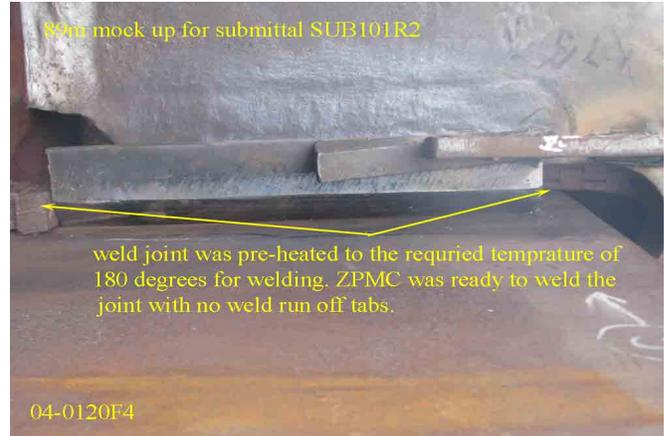
This Quality Assurance (QA) inspector arrived at ZPMC in Shanghai China for observations of the Orthotropic Bridge Girders (OBG) and Self Anchored Suspension (SAS) Bridge. During this QA inspector observation of the 89m partial mock up under Submittal SUB101R2 it was noted that ZPMC had fit up the lug plate to stiffener and diaphragm plate. ZPMC was observed pre heating this location for welding. It was noted that under the above noted submittal that ZPMC did not follow the procedures which stated in item 3 "Weld new PJP root pass between longitudinal stiffener and diaphragm according to approved WPS including preheat to between 180 and 240 degrees C. Submit welding data" the diaphragm to stiffener was to be welded first in sequence which ZPMC did not do. ZPMC elected to perform item 9 "Weld Fit lug to stiffener using equivalent PJP weld each side" which was the fit lug to stiffener and diaphragm. Welding was halted due to not enough time to perform the welding and cool down operations but was to continue on the day shift 7-17-08. Also noted was ZPMC did not attach weld run off tabs for the PJP weldments. The PJP weld joints were preheated to 180 degrees and ready for welding which showed intent of not using run off tabs due to the requirements of preheating run off tabs along with the weld joint together. The above issues were outside the procedure outlined in the approved submittal and a TL-15 incident report was issued.
