**DEPARTMENT OF TRANSPORTATION**

Contract #: 04-0120F4Cty: SF/ALA Rte: 80 PM: 13.2/13.9File #: 69.28**WELDING INSPECTION REPORT****Resident Engineer:** Pursell, Gary**Address:** 333 Burma Road**City:** Oakland, CA 94607**Report No:** WIR-003523**Date Inspected:** 08-Aug-2008**Project Name:** SAS Superstructure**OSM Arrival Time:** 630**Prime Contractor:** American Bridge/Fluor Enterprises, a JV**OSM Departure Time:** 1530**Contractor:** Zhenhua Port Machinery Company, Ltd (ZPMC), Changxing Island **Location:** Shanghai, China

# WELDING INSPECTION REPORT

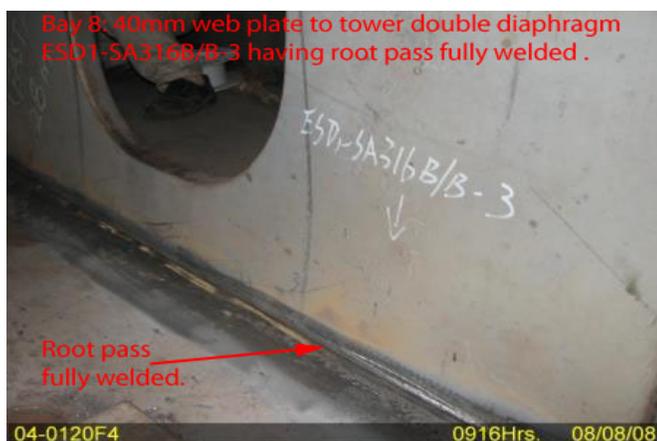
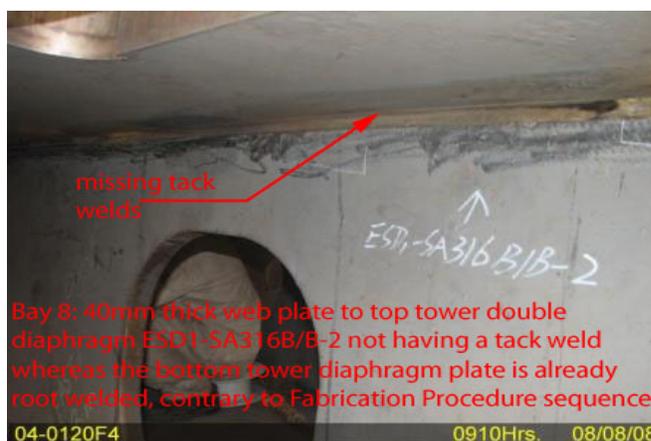
This QA observed tack welding of 40mm web plate to tower double diaphragm (top) ESD1-SA316 B/B weld joints 1, 2, 7 & 8 but the bottom welds 3, 4, 5 and 6 were already root welded which is contrary to the fabrication procedure steps 2 and 3 of FP-MUA-20 wherein both top and bottom web plates/stiffeners should only be tack welded prior welding one side of the tower double diaphragm. See photo below.
