DEPARTMENT OF TRANSPORTATION

Contract #: 04-0120F4Cty: SF/ALA Rte: 80 PM: 13.2/13.9File #: 69.28**WELDING INSPECTION REPORT****Resident Engineer:** Pursell, Gary**Address:** 333 Burma Road**City:** Oakland, CA 94607**Report No:** WIR-003584**Date Inspected:** 22-Jul-2008**Project Name:** SAS Superstructure**OSM Arrival Time:** 700**Prime Contractor:** American Bridge/Fluor Enterprises, a JV**OSM Departure Time:** 1500**Contractor:** Zhenhua Port Machinery Company, Ltd (ZPMC), Changxing Island **Location:** Shanghai, China**CWI Name:** Sun Wei**CWI Present:** Yes No**Inspected CWI report:** Yes No N/A**Rod Oven in Use:** Yes No N/A**Electrode to specification:** Yes No N/A**Weld Procedures Followed:** Yes No N/A**Qualified Welders:** Yes No N/A**Verified Joint Fit-up:** Yes No N/A**Approved Drawings:** Yes No N/A**Approved WPS:** Yes No N/A**Delayed / Cancelled:** Yes No N/A**Bridge No:** 34-0006**Component:** Tower and OBG**Summary of Items Observed:**

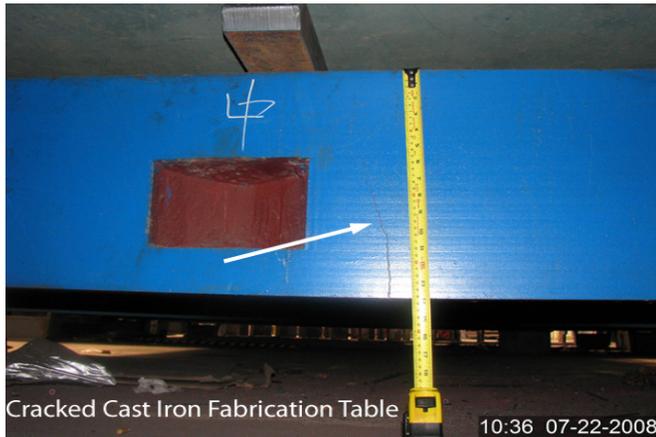
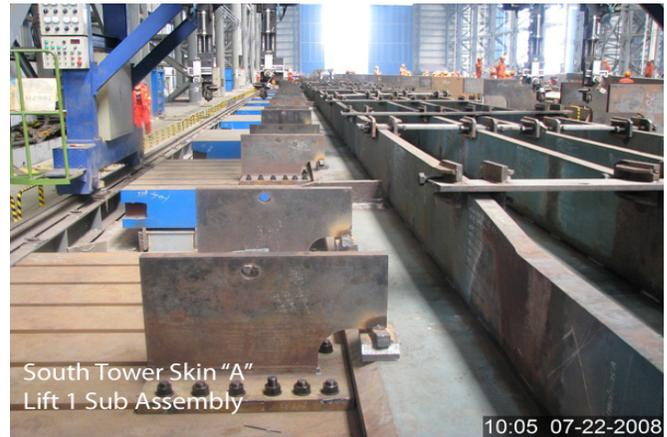
Tower Bay 1

The Quality Assurance Inspector was informed by ABF representative Don Walton that several of the fabrication tables cracked during the fabricators attempt to pre-camber the South tower, skin "A", lift 1, sub-assembly. QA observed that 10 of the 12 tables were cracked. ZPMC had placed a steel plate down the centerline of the skin measuring approximately 40 millimeters in thickness and 100 millimeters in width. ZPMC forced one side of the skin plate down with the use of steel wedges while jacking the other side with approximately 12, 30 ton hydraulic jacks. It is assumed by ABF representative Mr. Walton; the cracks took place while jacking. Below are digital photographs illustrating the process.
