DEPARTMENT OF TRANSPORTATION

Contract #: 04-0120F4Cty: SF/ALA Rte: 80 PM: 13.2/13.9File #: 69.28**WELDING INSPECTION REPORT****Resident Engineer:** Pursell, Gary**Address:** 333 Burma Road**City:** Oakland, CA 94607**Report No:** WIR-003638**Date Inspected:** 11-Aug-2008**Project Name:** SAS Superstructure**OSM Arrival Time:** 1400**Prime Contractor:** American Bridge/Fluor Enterprises, a JV**OSM Departure Time:** 2230**Contractor:** Zhenhua Port Machinery Company, Ltd (ZPMC), Changxing Island **Location:** Shanghai, China

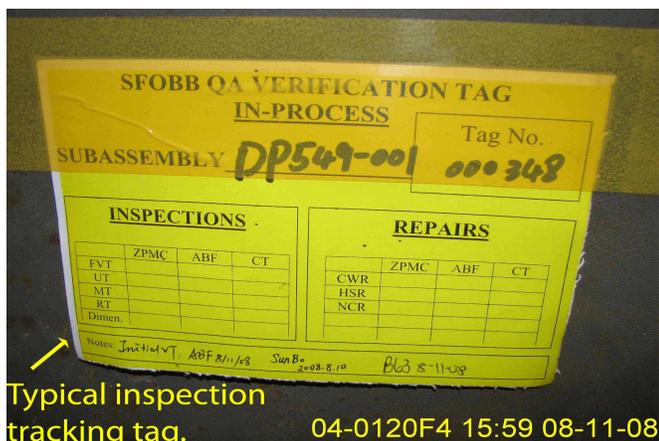
Around 1500 hours ZPMC QC representative Mr. Fu Yuhong informed the QA Inspector that ZPMC QC and ABF QA Inspection personnel have completed initial visual inspections of deck panels DP584-001 and DP549-001 and the areas of the closed rib welds that need to be repaired have been marked by soapstone. The QA Inspector performed random visual inspections of each of the welds on deck panels DP584-001 and DP549-001 and the approximately ten additional areas of weld overlap were identified by the QA Inspector as needing to be repaired. The QA Inspector documented the initial visual inspections on the yellow inspection status tag that is attached to each of the two deck panels. See the photograph below for additional information.
