**DEPARTMENT OF TRANSPORTATION**

Contract #: 04-0120F4Cty: SF/ALA Rte: 80 PM: 13.2/13.9File #: 69.28**WELDING INSPECTION REPORT****Resident Engineer:** Pursell, Gary**Address:** 333 Burma Road**City:** Oakland, CA 94607**Report No:** WIR-003797**Date Inspected:** 04-Sep-2008**Project Name:** SAS Superstructure**OSM Arrival Time:** 1400**Prime Contractor:** American Bridge/Fluor Enterprises, a JV**OSM Departure Time:** 2300**Contractor:** Zhenhua Port Machinery Company, Ltd (ZPMC), Changxing Island **Location:** Shanghai, China**CWI Name:** Zhang Bao Lei**CWI Present:** Yes No**Inspected CWI report:** Yes No N/A**Rod Oven in Use:** Yes No N/A**Electrode to specification:** Yes No N/A**Weld Procedures Followed:** Yes No N/A**Qualified Welders:** Yes No N/A**Verified Joint Fit-up:** Yes No N/A**Approved Drawings:** Yes No N/A**Approved WPS:** Yes No N/A**Delayed / Cancelled:** Yes No N/A**Bridge No:** 34-0006**Component:** OBG side, bottom and deck panels**Summary of Items Observed:**

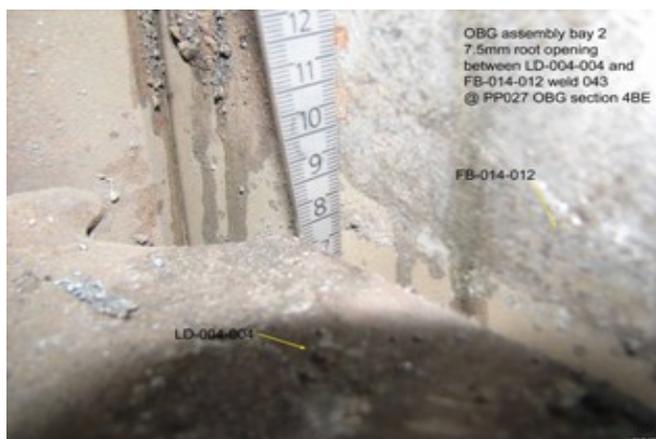
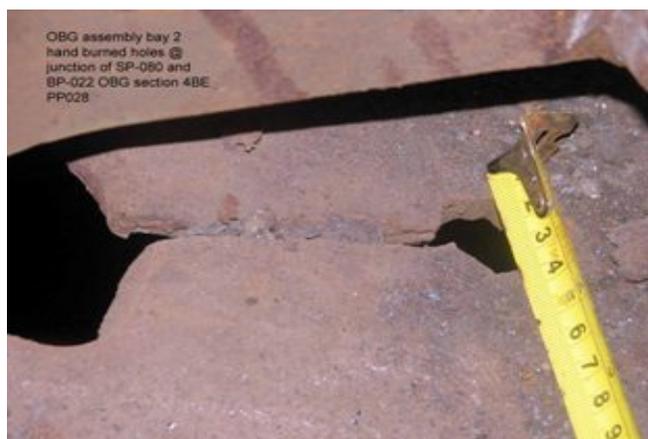
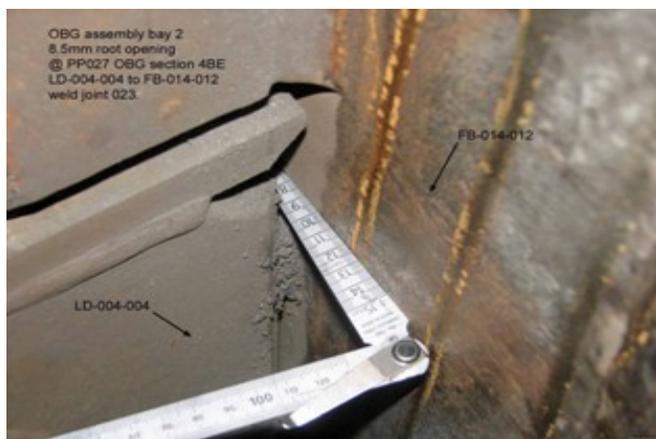
QA observed that ZPMC has fit and tacked longitudinal shear plate at PP027 on OBG section 4BE leaving an excessive root opening of 8.5mm between the web of the shear plate and the web of the floor beam that it will weld to. This exceeds the tolerances specified in AWS D1.5 2002 figure 2.4 joint designation TC-U4b "root opening = 0 - 3 / +2 -3" and paragraph 3.3.4. Paragraph 3.3.4.1 also states "Root openings wider than those allowed in 3.3.4, but not greater than twice the thickness of the thinner part or 20 mm [3/4 in.], whichever is less, may be corrected by welding to acceptable dimensions prior to joining the parts by welding". ZPMC has already joined these parts by tack welding.

QA also observed that ZPMC has hand burned "rat holes" at the junction of side plate SP-080-001 and BP-022-001 @ PP-028 OBG section 4BE. These holes are detailed on the drawings however hand burning is prohibited per AWS D1.5 2002 paragraph 3.2.2: "Freehand thermal cutting shall be done only where approved by the Engineer". QA notified ZPMC QC Lead CWI identified as Mr. Zhang Bao Lei and ABF representative identified as Mr. Steve Lawton of QA's intention to submit an incident report for both of these issues. See attached photos below.
