DEPARTMENT OF TRANSPORTATION

Contract #: 04-0120F4Cty: SF/ALA Rte: 80 PM: 13.2/13.9File #: 69.28**WELDING INSPECTION REPORT****Resident Engineer:** Pursell, Gary**Address:** 333 Burma Road**City:** Oakland, CA 94607**Report No:** WIR-003800**Date Inspected:** 01-Sep-2008**Project Name:** SAS Superstructure**OSM Arrival Time:** 1400**Prime Contractor:** American Bridge/Fluor Enterprises, a JV**OSM Departure Time:** 2300**Contractor:** Zhenhua Port Machinery Company, Ltd (ZPMC), Changxing Island **Location:** Shanghai, China**CWI Name:** Sun Wei**CWI Present:** Yes No**Inspected CWI report:** Yes No N/A**Rod Oven in Use:** Yes No N/A**Electrode to specification:** Yes No N/A**Weld Procedures Followed:** Yes No N/A**Qualified Welders:** Yes No N/A**Verified Joint Fit-up:** Yes No N/A**Approved Drawings:** Yes No N/A**Approved WPS:** Yes No N/A**Delayed / Cancelled:** Yes No N/A**Bridge No:** 34-0006**Component:** OBG deck panel DP-440-001**Summary of Items Observed:**

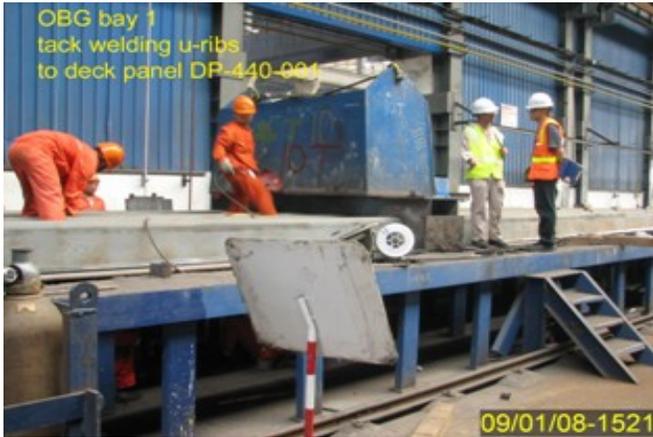
QA observed ZPMC tack welding uribs to deck panel DP-440-001. While observing the tack welding, QA noted that when the welder was "back filling" the crater at the end of the tack, the welding wire speed slowed dramatically. This reduction in wire speed also reduced the welding amperage from 328 amps to 121 amps and the voltage from 29 volts to 17 volts as measured with QAs calibrated Fluke multi meter. WPS# WPS-B-T-2342-U2-(urib) specifies the amps to be 320.4 to 350 and the volts to be 28.5 to 32.7 and makes no mention of reducing the amps and volts to back fill the crater at the end of the tack. ZPMC CWI identified as Mr. Sun Wei informed this QA inspector that ZPMC's engineer instructed the welders to perform these tacks in this manner. QA recorded a video of the tacking process and put it on the team china Server for all concerned parties to view. It is under "Team OBG" the file name is "DP-440-001 tack video". Note how the wire speed on the wire feeder is reduced toward the end of the tacking process for approx. 2 to 3 seconds. Tacking of these ribs was incomplete at the end of the shift. QA and QC monitored the tack welding through out the evening. The welder ID and welding parameters as measured with Quality Controls calibrated instruments appeared to be in conformance with the posted WPS's with the exception of one end of the tacks as described above and were as follows:

Volts: 29 Amps: 328 Travel speed: 499mm/min

Welder ID: 059409
