**DEPARTMENT OF TRANSPORTATION**

Contract #: 04-0120F4Cty: SF/ALA Rte: 80 PM: 13.2/13.9File #: 69.28**WELDING INSPECTION REPORT****Resident Engineer:** Pursell, Gary**Address:** 333 Burma Road**City:** Oakland, CA 94607**Report No:** WIR-003892**Date Inspected:** 09-Sep-2008**Project Name:** SAS Superstructure**OSM Arrival Time:** 700**Prime Contractor:** American Bridge/Fluor Enterprises, a JV**OSM Departure Time:** 1700**Contractor:** Zhenhua Port Machinery Company, Ltd (ZPMC), Changxing Island **Location:** Shanghai, China**CWI Name:** Sun Wei**CWI Present:** Yes No**Inspected CWI report:** Yes No N/A**Rod Oven in Use:** Yes No N/A**Electrode to specification:** Yes No N/A**Weld Procedures Followed:** Yes No N/A**Qualified Welders:** Yes No N/A**Verified Joint Fit-up:** Yes No N/A**Approved Drawings:** Yes No N/A**Approved WPS:** Yes No N/A**Delayed / Cancelled:** Yes No N/A**Bridge No:** 34-0006**Component:** OBG**Summary of Items Observed:**

**OBG Assembly**

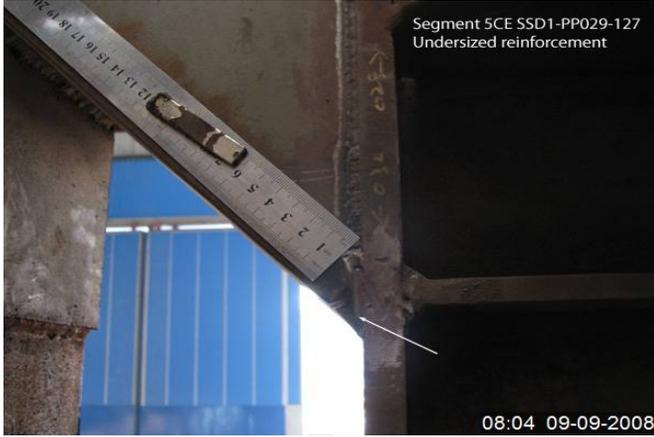
The Quality Assurance Inspector observed numerous sloping flange plate connections with undersized reinforcement. Weld detail WD20N requires a reinforcing fillet to be 5 millimeters on the acute side, and 8 millimeters on the obtuse side. The following is a list of weld numbers accepted by ZPMC visually and by the required non destructive testing; SSD19-PP029-131, SSD19-PP029-127, SSD17A-PP021-009, SSD17A-PP021-126, SSD13A-PP036-131, and SSD13A-PP036-127. The Quality Assurance Inspector observed several others of the same connection that appears to be completed however it is not clear that ZPMC has completed visual and non destructive testing requirements. The Quality Assurance Inspector generated an incident report pertaining to the discrepancy. Below is a digital photograph illustrating the discrepancy.

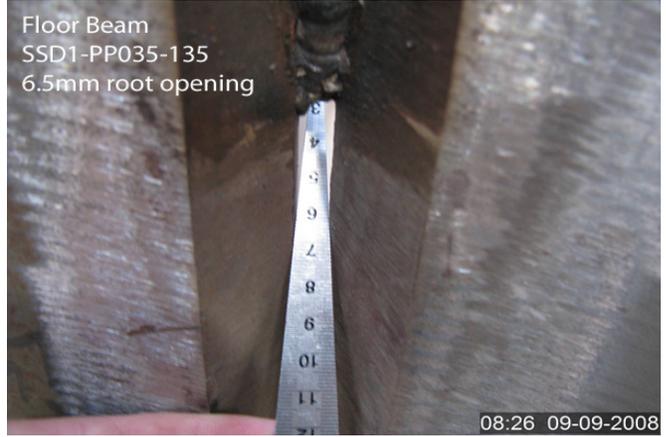
**Segment 5BE**

The Quality Assurance observed an excessive root opening measuring approximately 6.5 millimeters at floor beam SSD1-PP035-135. ABF Representative Peter Shaw was informed of the discrepancy. Mr. Shaw stated ZPMC was planning to weld the joint with metal backing rather than welding it as detailed as a double V complete joint penetration weld. Below is a digital photograph illustrating the discrepancy.

The Quality Assurance observed an excessive root opening measuring approximately 6.5 millimeters at floor beam SSD1-PP035-135. ABF Representative Peter Shaw was informed of the discrepancy. Mr. Shaw stated ZPMC was planning to weld the joint in it's as built condition. The Quality Assurance informed Mr. Shaw that a Non Conformance would be generated if the joint was welded with an excessive root opening.
