DEPARTMENT OF TRANSPORTATION

Contract #: 04-0120F4Cty: SF/ALA Rte: 80 PM: 13.2/13.9File #: 69.28**WELDING INSPECTION REPORT****Resident Engineer:** Pursell, Gary**Address:** 333 Burma Road**City:** Oakland, CA 94607**Report No:** WIR-000036**Date Inspected:** 04-Dec-2006**Project Name:** SAS Superstructure**OSM Arrival Time:** 800**Prime Contractor:** American Bridge/Fluor Enterprises, a JV**OSM Departure Time:** 1700**Contractor:** Zhenhua Port Machinery Company, Ltd (ZPMC), Changxing Island **Location:** Shanghai, China

Office of Structural Materials Quality Assurance Inspector (QA), David McClary observed quality control functions related to procedure qualification (PQR) testing at the ZPMC facility in Shanghai, China for the San Francisco Oakland Bay Self Anchored Suspension Bridge.

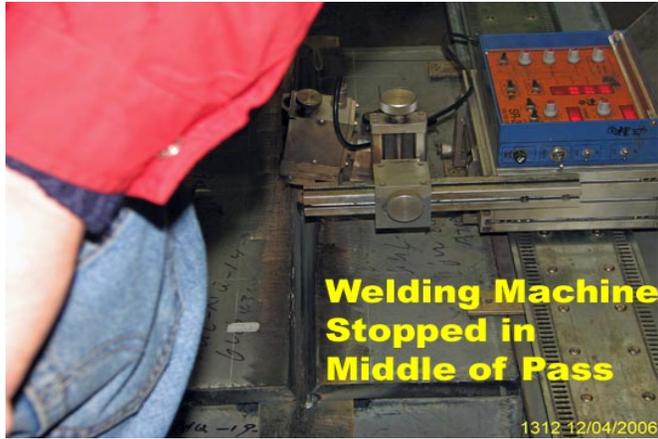
The QA Inspector observed welding of a Procedure Qualification (PQR) test plate identified as HP-2006107-2 (retest). The test was conducted using Flux Cored Arc Welding (FCAW), Hyundai Supercored 71H, electrode in the 1G (flat) position to AWS D1.5, Section 5.12.1 (Maximum Heat Input). ZPMC began the test, but were outside the +/- 10% allowable travel speed range by the second pass of the root layer. The first pass was conducted at 266.7 mm/min and the second at 355.4 mm/min, which gave them a +/- 14% difference from the average. ZPMC prepared another test plate and began the PQR again. On the second pass of a two pass root layer, the welding machine stopped in the middle of the pass because it ran out of electrode wire. The QA Inspector observed ZPMC Quality Control (QC) recording the essential variable (amps, volts, travel speed) for each pass and randomly verified the parameters using a Fluke® amperage / voltage meter and a stopwatch. The welding appeared to comply with the contract documents. Note: ZPMC performed a two pass root to ensure thorough fusion at the root. Lot Number B60-028-06 was assigned for tracking purposes. See TL-6032 for additional details.

ZPMC Quality Control (QC) director Mr. Liu Liu informed the QA Inspector that the Radiographic Testing (RT) film for the 1G FCAW PQR re-test was rejected by ZPMC Quality Control for lack of fusion.
