Contract #: 04-0120F4
 Cty: SF/ALA Rte: 80 PM: 13.2/13.9
 File #: 69.28

WELDING INSPECTION REPORT

Report No: WIR-000043
Date Inspected: 04-Nov-2006

Project Name: SAS Superstructure **OSM Arrival Time:** 830
Prime Contractor: American Bridge/Fluor Enterprises, a JV **OSM Departure Time:** 1730
Contractor: Zhenhua Port Machinery Company, Ltd (ZPMC), Changxing Island **Location:** Shanghai, China

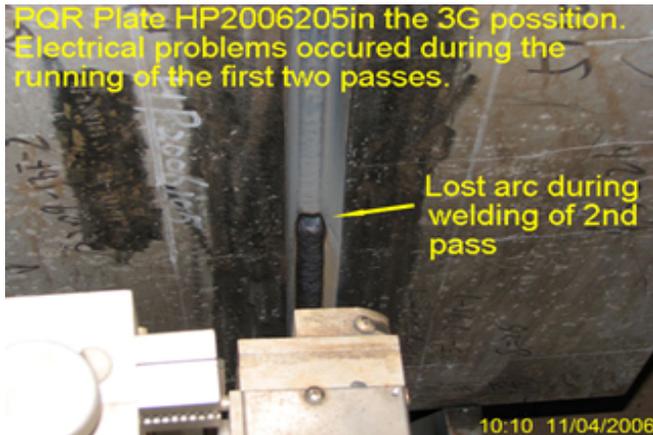
This Quality Assurance Inspector observed the Quality Control Inspector, Mr. Liu Liu witnessing the running of the flux core arc welding procedure qualification test HP2006105 in the shop at ZPMC. The test was being run to Paragraph 5.12 at the maximum heat input in the vertical welding position (3G). The welders were Lei Li Chao and Zhang Xing Jin who were using Hyundai, Supercored 71, and 1.4 millimeter diameter wire. Problems occurred during the running of the root weld due to power fluctuation and then again during the second pass.

A discussion was held with Liu Liu concerning the power fluctuations. Mr. Liu stated that they were going to suspend welding of the flux core welding to look into the cause of the electrical power problems.
