DEPARTMENT OF TRANSPORTATION

Office of Structural Materials

Contract #: 04-0120F4Cty: SF/ALA Rte: 80 PM: 13.2/13.9File #: 69.28**WELDING INSPECTION REPORT****Resident Engineer:** Pursell, Gary**Address:** 333 Burma Road**City:** Oakland, CA 94607**Report No:** WIR-000050**Date Inspected:** 05-Jan-2007**Project Name:** SAS Superstructure**OSM Arrival Time:** 800**Prime Contractor:** American Bridge/Fluor Enterprises, a JV**OSM Departure Time:** 1700**Contractor:** Zhenhua Port Machinery Company, Ltd (ZPMC), Changxing Island **Location:** Shanghai, China

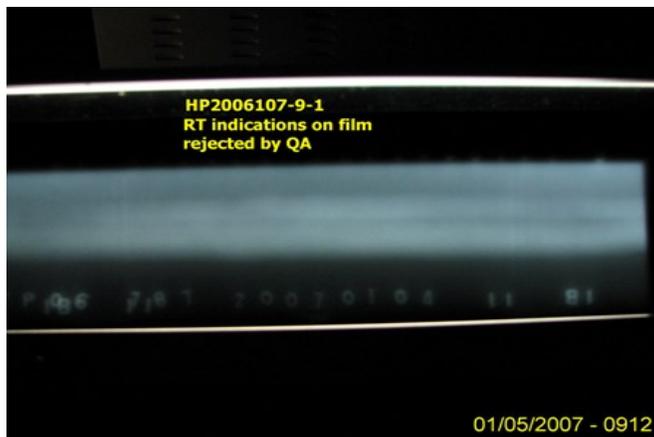
The QA Inspector reviewed the Radiographic Testing (RT) film for 1G (horizontal) Flux Core Arc Welding (FCAW) Procedure Qualification (PQR) identified as HP-2006107-9-1. The QA Inspector observed indications on the film in the area of interest which did not comply with figure 6.8 of AWS D1.5-2002. The Quality Control for ZPMC stated that the weld cap would be ground down and the PQR plate re-shot by radiographic testing.

The Quality Control (QC) representative for ZPMC stated that the indications on the film was from the weld cap and that he believed that the weld was good. The QA stated that the weld cap would have to be removed as per contract documents prior to radiographic testing so that the weld cap would not mask any defects in the weld zone.

The QC stated that the code allowed the weld reinforcement to remain. The QA reconfirmed that the welds to be radiographed shall be ground smooth and flush as per the Standard Specifications.
