DEPARTMENT OF TRANSPORTATION

Contract #: 04-0120F4Cty: SF/ALA Rte: 80 PM: 13.2/13.9File #: 1.28**WELDING INSPECTION REPORT****Resident Engineer:** Pursell, Gary**Address:** 333 Burma Road**City:** Oakland, CA 94607**Report No:** WIR-000135**Date Inspected:** 25-Apr-2007**Project Name:** SAS Superstructure**OSM Arrival Time:** 630**Prime Contractor:** American Bridge/Fluor Enterprises, a JV**OSM Departure Time:** 1500**Contractor:** American Bridge/Fluor Enterprises, a JV**Location:** Benicia, California

Bridge No: 34-0006**Component:** Procedure Qualification Record (PQR) Tests**Summary of Items Observed:**

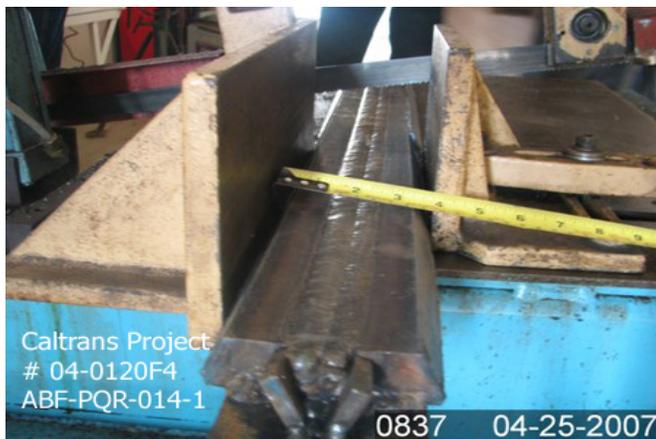
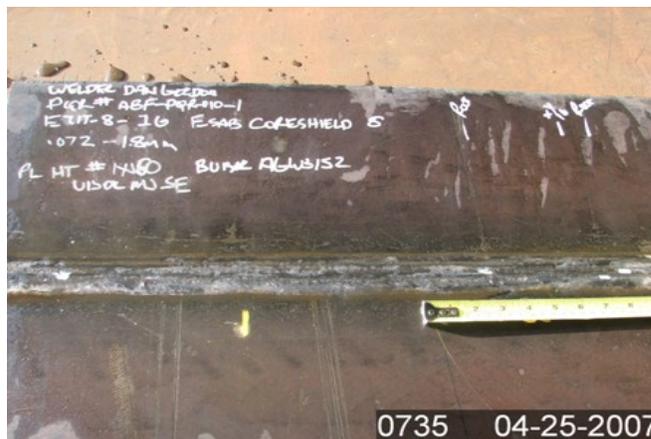
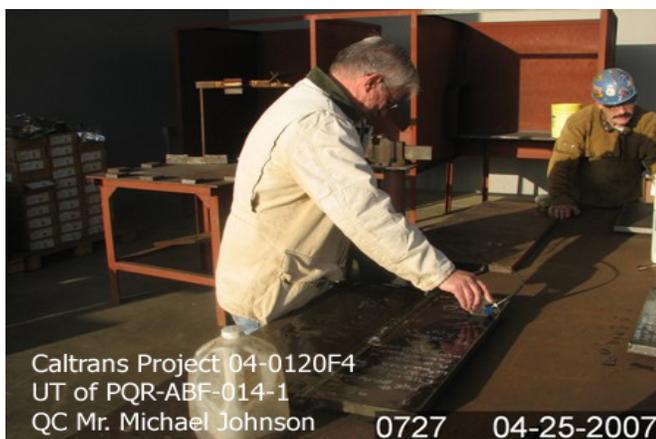
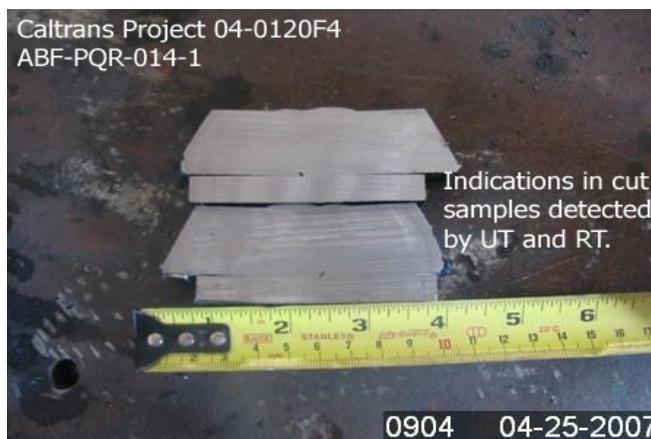
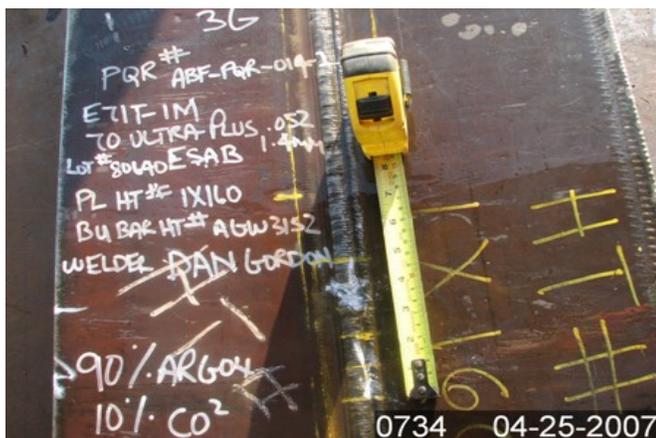
The QA Inspector observed QC Mr. Michael Johnson performing Ultrasonic Testing (UT) on two Procedure Qualification Record (PQR) Tests identified as ABF-PQR-014-1 and ABF-PQR-010-1. Mr. Johnson elected to perform UT on the two test plates in an effort to determine the location and possibly the type of discontinuities found during Radiographic Testing (RT) on the previous date. During testing, Mr. Johnson mapped out various indications on each weld. After UT was completed, Mr. Johnson stated that the indications detected during UT are located in root area of each weld.

A short time later, ABF Representative Mr. Tommy Gibson elected to cut the test plate identified as ABF-PQR-014-1 in the areas marked by Mr. Johnson in an attempt to determine the cause of the RT failure. Digital photographs of the samples cut from this PQR are included within this report.

ABF Representative Mr. Tommy Gibson informed the QA Inspector that the two Procedure Qualification Record (PQR) Tests x-rayed on the previous date were rejected by the Davis Laboratories, Incorporated Representative Mr. Matt Schonhoff. These two PQRs are identified as ABF-PQR-014-1 and ABF-PQR-010-1.

At approximately 1200 hours, QC Mr. Michael Johnson informed the QA Inspector that ABF would weld several passes on a practice test plate in preparation for a second attempt at the PQR identified as ABF-PQR-014-1. In addition, Mr. Johnson stated that Mr. Gordon would weld the practice plate on this date and begin the identified
