**DEPARTMENT OF TRANSPORTATION**

Contract #: 04-0120F4Cty: SF/ALA Rte: 80 PM: 13.2/13.9File #: 01.28**WELDING INSPECTION REPORT****Resident Engineer:** Pursell, Gary**Address:** 333 Burma Road**City:** Oakland, CA 94607**Report No:** WIR-000157**Date Inspected:** 04-May-2007**Project Name:** SAS Superstructure**OSM Arrival Time:** 630**Prime Contractor:** American Bridge/Fluor Enterprises, a JV**OSM Departure Time:** 1030**Contractor:** American Bridge/Fluor Enterprises, a JV**Location:** Benicia, CA**CWI Name:** Michael Johnson**CWI Present:** Yes No**Inspected CWI report:** Yes No N/A**Rod Oven in Use:** Yes No N/A**Electrode to specification:** Yes No N/A**Weld Procedures Followed:** Yes No N/A**Qualified Welders:** Yes No N/A**Verified Joint Fit-up:** Yes No N/A**Approved Drawings:** Yes No N/A**Approved WPS:** Yes No N/A**Delayed / Cancelled:** Yes No N/A**Bridge No:** 34-0006**Component:** Procedure Qualification Record (PQR) Test**Summary of Items Observed:**

# WELDING INSPECTION REPORT

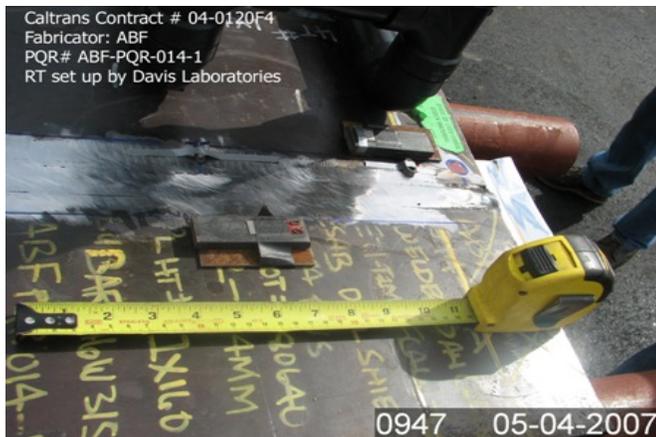
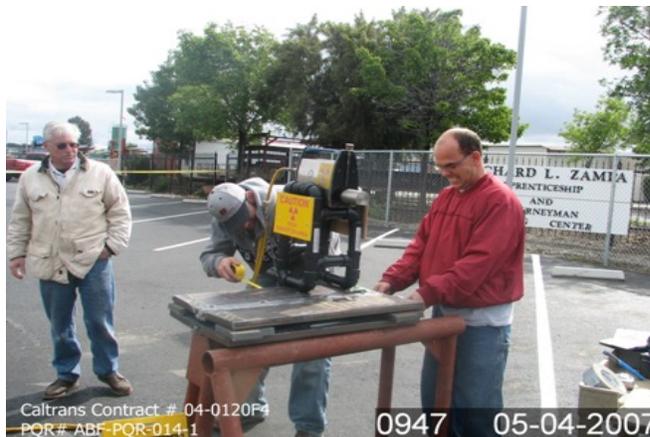
The QA Inspector observed Davis Laboratories, Incorporated Radiographic Technician Mr. Matt Schonhoff, as he prepared to perform Radiographic Testing (RT) on two Procedure Qualification Record (PQR) Test Plates identified as ABF-PQR-014-1 and ABF-PQR-013-1. The QA Inspector observed Mr. Schonhoff's equipment set up after the first exposure and verified compliance with AWS D1.5 2002, Figure 6.1A. After Mr. Schonhoff removed his film from the first exposure, the QA Inspector observed that Mr. Schonhoff was not using a lead symbol "B" on the back side of his film cassette as required by AWS D1.5 2002, Section 6.10.8.2. The QA Inspector addressed this issue with Mr. Schonhoff. Mr. Schonhoff agreed with the QA Inspector and then elected to discard the first exposure, attach a lead symbol "B" to his film cassette, and expose another piece of film. See the following digital photographs for additional information.

At approximately 1400 hours, Quality Control Representative Mr. Michael Johnson informed the QA Inspector that the Procedure Qualification Record (PQR) Test plates identified as ABF-PQR-014-1 and ABF-PQR-013-1 were rejected by Davis Laboratories RT Technician, Mr. Matt Schonhoff.
