Contract #: 04-0120F4Cty: SF/ALA Rte: 80 PM: 13.2/13.9File #: 69.28**WELDING INSPECTION REPORT****Resident Engineer:** Pursell, Gary**Address:** 333 Burma Road**City:** Oakland, CA 94607**Report No:** WIR-000221**Date Inspected:** 12-Jun-2007**Project Name:** SAS Superstructure**OSM Arrival Time:** 800**Prime Contractor:** American Bridge/Fluor Enterprises, a JV**OSM Departure Time:** 1730**Contractor:** Zhenhua Port Machinery Company, Ltd (ZPMC), Changxing Island **Location:** Shanghai, China

Item	Description	WBS	Dwg No.	Status
1	Mock-Up Material Verification	N/A	N/A	N/A

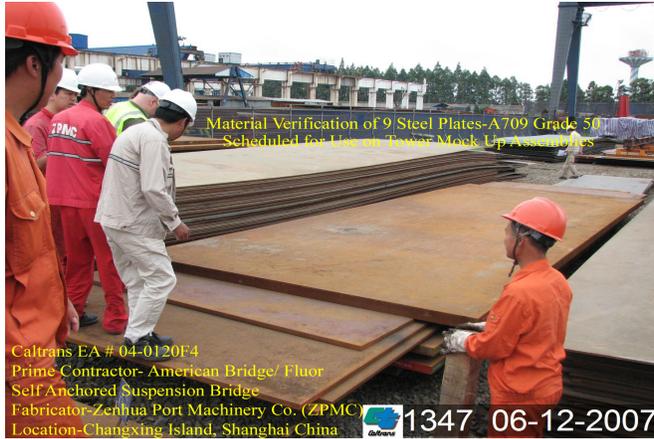
The Caltrans QA Inspector's presence was requested by ABF representative Mr. Jeff Evans for the purpose of observing nine (9) steel plates scheduled for use on the tower mock up assemblies. The Caltrans QA Inspector was escorted along with Mr. Jeff Evans by Mr. Fu Yuhong of ZPMC. The Caltrans QA Inspector observed that the presented steel plates are identified as A709 Grade 50 material and are of thicknesses of 25mm, 35mm, 60mm, 70mm and 90mm with a variety of size dimensions. The appearance of these plates contained rust and are in a stacked position as identified in the picture below.

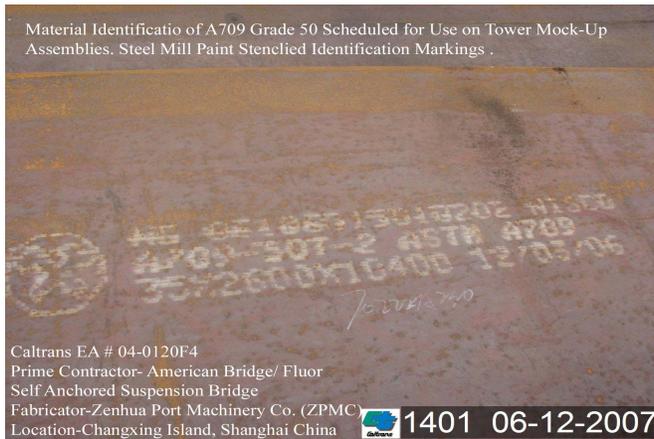
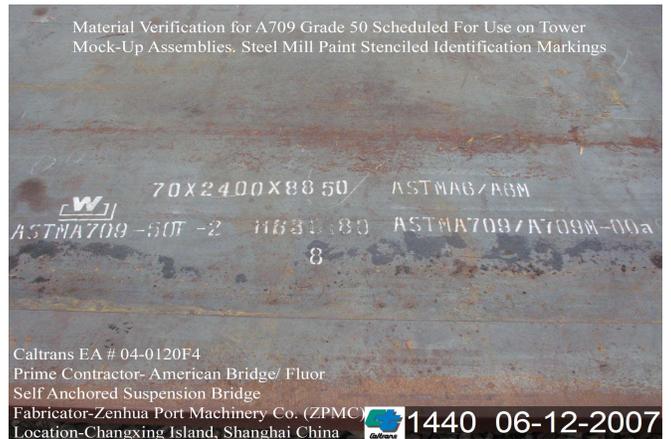
2 Mock-Up Material Verification N/A N/A N/A

ZPMC unstacked each plate to provide visible access to the surface that contained the producing steel mills painted identification markings stencil. The Caltrans QA Inspector observed that the painted identification markings were not all easily legible as identified in the digital picture below. The Caltrans QA Inspector did identify that some of the steel plates did contain identification markings that were clearly legible as identified within the digital picture below. Some of the steel plates presented contained steel died stencils that were identifiable as well as some that could not be identified.

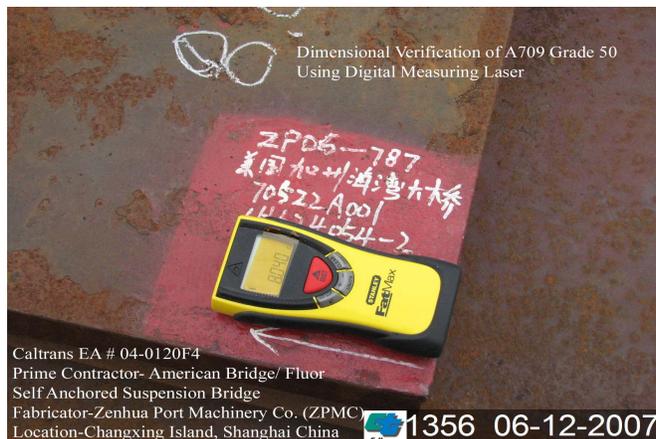
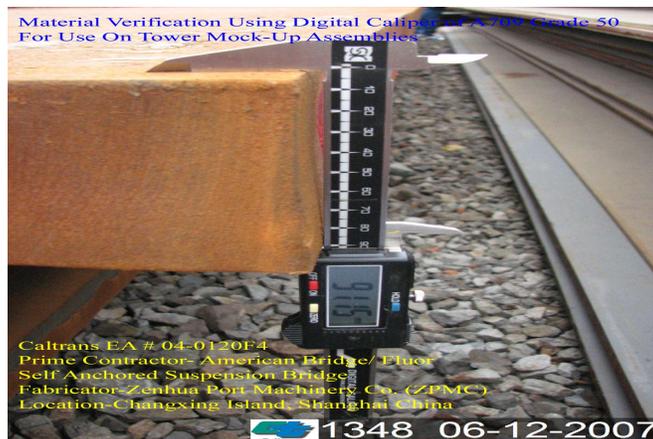
3 Mock Up Material Verification N/A N/A N/A

The Caltrans QA Inspector performed dimensional measurements utilizing a digital caliper for measuring plate thicknesses and also a laser for measuring the width and lengths of randomly selected plates as identified within the digital pictures below. The ABF representative did not perform any dimensional verification of the presented steel plates while the Caltrans QA Inspector was present.
