**DEPARTMENT OF TRANSPORTATION**

Contract #: 04-0120F4Cty: SF/ALA Rte: 80 PM: 13.2/13.9File #: 69.28**WELDING INSPECTION REPORT****Resident Engineer:** Pursell, Gary**Address:** 333 Burma Road**City:** Oakland, CA 94607**Report No:** WIR-000222**Date Inspected:** 11-Jun-2007**Project Name:** SAS Superstructure**OSM Arrival Time:** 800**Prime Contractor:** American Bridge/Fluor Enterprises, a JV**OSM Departure Time:** 1730**Contractor:** Zhenhua Port Machinery Company, Ltd (ZPMC), Changxing Island **Location:** Shanghai, China

# WELDING INSPECTION REPORT

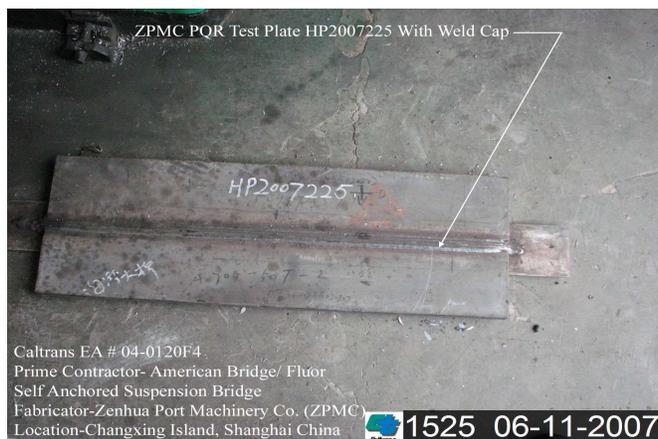
2) PQR Test Plate HP2007225- The Caltrans QA Inspector observed that the presented radiographs for this PQR test plate contain linear indications that are not in compliance with the requirements of AWS D1.5 (2002). It is inconclusive as to whether or not the PQR test plate weld cap with multiple weld passes represents the linear indications within the radiographs. The Caltrans QA Inspector and ZPMC representative Mr. Lu Jian Hua visually observed that the PQR test plate weld cap had not been ground flush prior to radiographic testing. Mr. Lu Jian Hua stated that the weld cap needed to be ground and subsequently radiographically tested again. Radiographic film reviewers for ZPMC and ABF representative Mr. Nate Lindell did not address this issue prior to this review by the

Caltrans QA Inspector. Included below is the digital picture of the PQR test plate which contains the unground weld cap.
