**DEPARTMENT OF TRANSPORTATION**

Contract #: 04-0120F4Cty: SF/ALA Rte: 80 PM: 13.2/13.9File #: 01.28**WELDING INSPECTION REPORT****Resident Engineer:** Pursell, Gary**Address:** 333 Burma Road**City:** Oakland, CA 94607**Report No:** WIR-000272**Date Inspected:** 10-Jul-2007**Project Name:** SAS Superstructure**OSM Arrival Time:** 630**Prime Contractor:** American Bridge/Fluor Enterprises, a JV**OSM Departure Time:** 1700**Contractor:** American Bridge/Fluor Enterprises, a JV**Location:** Benicia, CA**CWI Name:** Michael Johnson**CWI Present:** Yes No**Inspected CWI report:** Yes No N/A**Rod Oven in Use:** Yes No N/A**Electrode to specification:** Yes No N/A**Weld Procedures Followed:** Yes No N/A**Qualified Welders:** Yes No N/A**Verified Joint Fit-up:** Yes No N/A**Approved Drawings:** Yes No N/A**Approved WPS:** Yes No N/A**Delayed / Cancelled:** Yes No N/A**Bridge No:** 34-0006**Component:** Procedure Qualification Record (PQR) Test**Summary of Items Observed:**

# WELDING INSPECTION REPORT

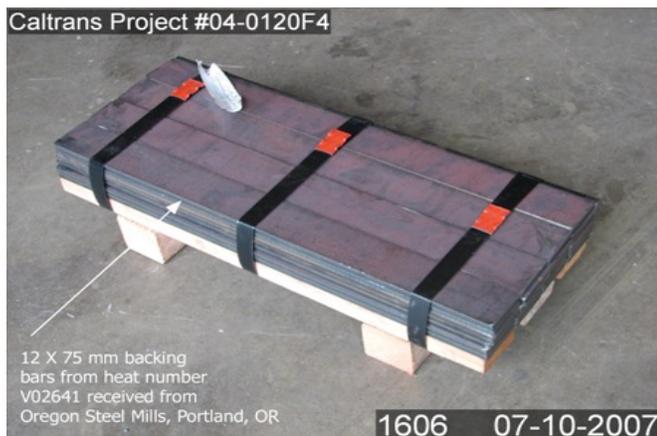
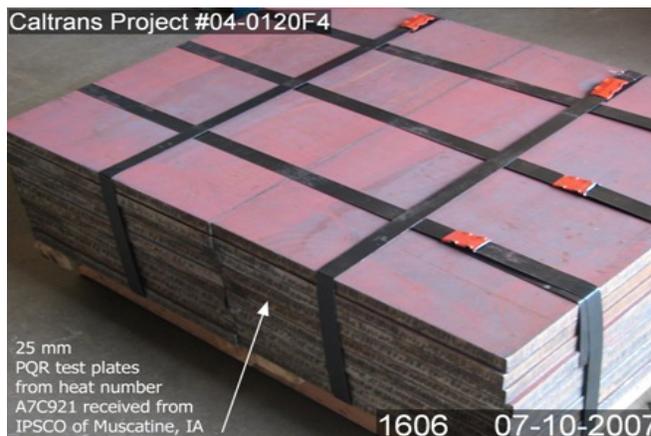
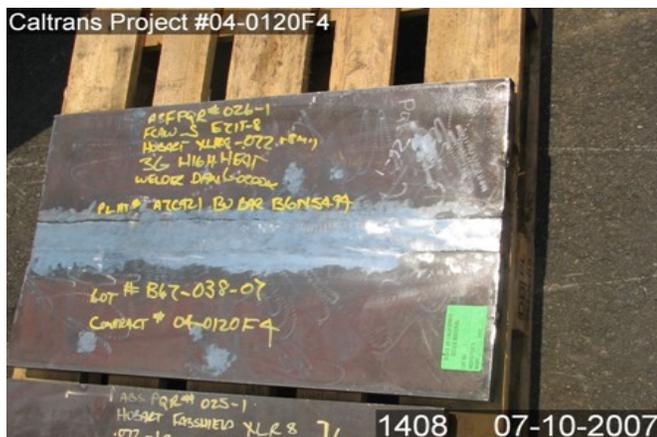
On this date, ABF received a pallet containing twenty-five millimeter PQR test plates and twelve millimeter backing bars. The QA Inspector performed a review of the contractor supplied mill test reports (MTR) which stated that the material received was melted and manufactured in the United States. The QA Inspector documented heat numbers for the material received on this date as follows: A7C921 for the test plates and V02641 for the backing bars.
