Contract #: 04-0120F4Cty: SF/ALA Rte: 80 PM: 13.2/13.9File #: 01.28**WELDING INSPECTION REPORT****Resident Engineer:** Pursell, Gary**Address:** 333 Burma Road**City:** Oakland, CA 94607**Report No:** WIR-000288**Date Inspected:** 12-Jul-2007**Project Name:** SAS Superstructure**OSM Arrival Time:** 630**Prime Contractor:** American Bridge/Fluor Enterprises, a JV**OSM Departure Time:** 1700**Contractor:** American Bridge/Fluor Enterprises, a JV**Location:** Benicia, CA

Bridge No: 34-0006**Component:** Procedure Qualification Record (PQR) Test**Summary of Items Observed:**

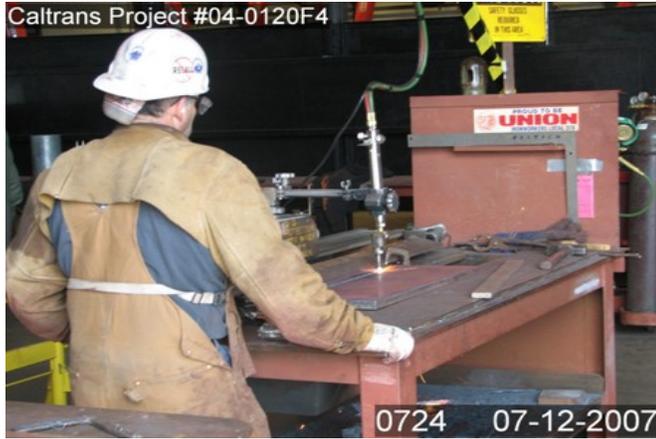
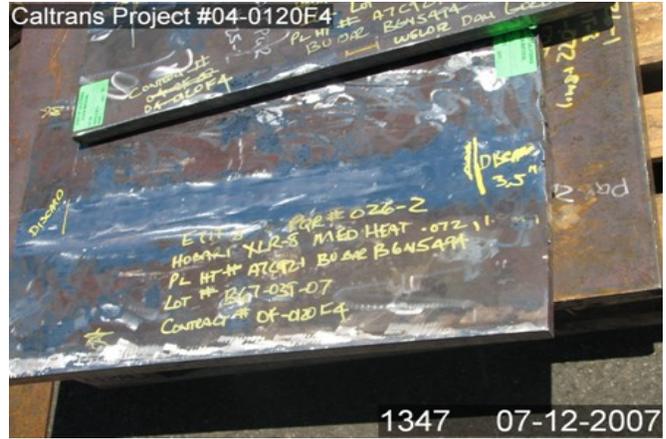
The QA Inspector witnessed the beginning of the first attempt of a PQR Test identified as ABF-PQR-005-1. This PQR test is being attempted using the flux-cored arc welding (FCAW) process and a mechanical device that travels on a magnetic track. Welder Dan Gordon deposited two weld passes on this date. ABF Representative Mr. Rick Clayborn partially removed each weld pass by grinding due to technical problems. For specific welding parameters recorded during this PQR and digital photographs that support these observations, see Caltrans Welding Witness Report, TL-6032 generated on this date.

The QA Inspector observed Quality Control Representative Mr. Michael Johnson as he performed visual inspection of a previously welded PQR plate identified as ABF-PQR-026-2. Following acceptance by Mr. Johnson, the QA Inspector performed a random visual inspection of the top and bottom sides of the identified PQR test plate. The QA Inspector then applied a green tag containing lot number B67-039-07 to the identified test plate. This PQR test plate will be sent out for radiographic testing in the week to follow.
