DEPARTMENT OF TRANSPORTATION

Contract #: 04-0120F4Cty: SF/ALA Rte: 80 PM: 13.2/13.9File #: 1.28**WELDING INSPECTION REPORT****Resident Engineer:** Pursell, Gary**Address:** 333 Burma Road**City:** Oakland, CA 94607**Report No:** WIR-000362**Date Inspected:** 14-Aug-2007**Project Name:** SAS Superstructure**OSM Arrival Time:** 700**Prime Contractor:** American Bridge/Fluor Enterprises, a JV**OSM Departure Time:** 1530**Contractor:** American Bridge/Fluor Enterprises, a JV**Location:** Benicia, CA**CWI Name:** Michael Johnson**CWI Present:** Yes No**Inspected CWI report:** Yes No N/A**Rod Oven in Use:** Yes No N/A**Electrode to specification:** Yes No N/A**Weld Procedures Followed:** Yes No N/A**Qualified Welders:** Yes No N/A**Verified Joint Fit-up:** Yes No N/A**Approved Drawings:** Yes No N/A**Approved WPS:** Yes No N/A**Delayed / Cancelled:** Yes No N/A**Bridge No:** 34-0006**Component:** Procedure Qualification Record (PQR) Test**Summary of Items Observed:**

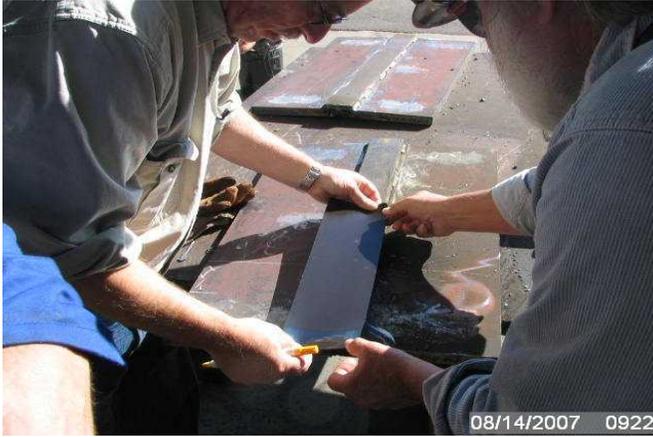
The QA Inspector observed that ABF and the ESAB Representative reviewed the previously rejected Radiographic Testing (RT) for PQR test plate known as ABF-PQR-011-1B and decided to remove a portion of the backing bar for informational purposes. ABF informed the QA Inspector that they believe the rejectable indications detected in the RT film could be in the backup bar. Mr. Johnson and Mr. Gibson used the original RT film to locate the indication on the back-side of the PQR plate after the backing bar was removed then used a yellow paint pen to transfer the indications marked on the RT film onto the back of the PQR plate prior to informational RT. This PQR plate was shipped for informational RT. See photo below for additional information.
