DEPARTMENT OF TRANSPORTATION

Contract #: 04-0120F4Cty: SF/ALA Rte: 80 PM: 13.2/13.9File #: 69.28**WELDING INSPECTION REPORT****Resident Engineer:** Pursell, Gary**Address:** 333 Burma Road**City:** Oakland, CA 94607**Report No:** WIR-000368**Date Inspected:** 15-Aug-2007**Project Name:** SAS Superstructure**OSM Arrival Time:** 800**Prime Contractor:** American Bridge/Fluor Enterprises, a JV**OSM Departure Time:** 1530**Contractor:** Zhenhua Port Machinery Company, Ltd (ZPMC), Changxing Island **Location:** Shanghai, China**CWI Name:** Xu Lefeng**CWI Present:** Yes No**Inspected CWI report:** Yes No N/A**Rod Oven in Use:** Yes No N/A**Electrode to specification:** Yes No N/A**Weld Procedures Followed:** Yes No N/A**Qualified Welders:** Yes No N/A**Verified Joint Fit-up:** Yes No N/A**Approved Drawings:** Yes No N/A**Approved WPS:** Yes No N/A**Delayed / Cancelled:** Yes No N/A**Bridge No:** 34-0006**Component:** N/A**Summary of Items Observed:**

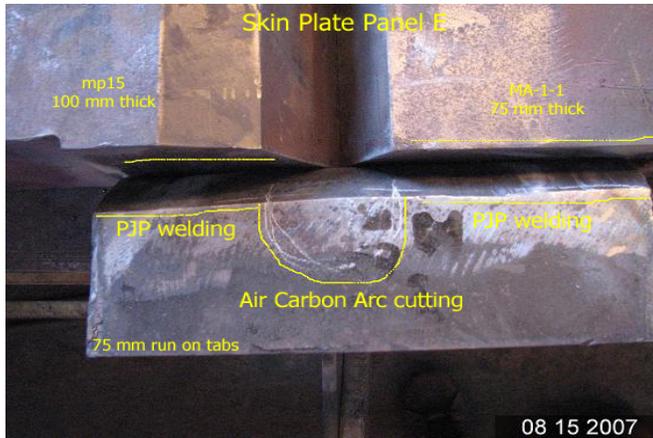
The CALTRANS Quality Assurance (QA) Inspector, Alfredo Acuna was present for the fabrication of the Mock-up 77 meters elevation scheduled for this project at the ZPMC facility in Shanghai, China for the San Francisco Oakland Bay Self Anchored Suspension Bridge. ZPMC started the installation of the run on tabs to the end of the double V groove joint for the partial penetration joint (PJP) at the skin plate panel E. The QA inspector observed that the first run on tab was a beveled approximately 20 mm of depth of preparation, and 40 ° bevel angle between the run on tab and the end of the skin plate panel E butt joint. See photo below. The QA inspector had a conversation with the ABF QA inspector Dustin Brungardt. The QA inspector questioned Mr. Brungardt as to what the purpose of the beveled groove on the run on, run off tabs were and also as to why they were positioned transverse to the skin plate splice groove weld. Mr. Brungardt questioned ZPMC. Mr. Brungardt did not have clear answer from ZPMC until Task Leader Dave McClary arrived to site. Mr. McClary questioned ZPMC in regards to the purpose of beveling the run on tabs with 20 to 30 mm of the preparation perpendicular to the weld axis. ZPMC representatives relayed that ZPMC was using a run on tabs with bevel angle and 20-30 mm depth of preparation for welding PJP to the skin plate. ZPMC added that when ZPMC welded ABF mock-ups they found cracks at the end of the joint; and by jointing the run on tabs with a partial penetration weld to the end of the skin plate, ZPMC would reduce the risk of cracking at the run on areas. The QA inspector conveyed to Mr. Brungardt the purpose of ZPMC beveling the run on tabs. Mr. Brungardt relayed to the QA inspector that he would bring to the attention of his supervisors the method that ZPMC was using to install the run on tabs. At the end of the QA shift ABF and ZPMC had not agreed on the run on tabs installation. ABF stopped ZPMC from welding the run on tabs while ZPMC and ABF were discussing.
