DEPARTMENT OF TRANSPORTATION

Contract #: 04-0120F4Cty: SF/ALA Rte: 80 PM: 13.2/13.9File #: 1.28**WELDING INSPECTION REPORT****Resident Engineer:** Pursell, Gary**Address:** 333 Burma Road**City:** Oakland, CA 94607**Report No:** WIR-000371**Date Inspected:** 22-Aug-2007**Project Name:** SAS Superstructure**OSM Arrival Time:** 700**Prime Contractor:** American Bridge/Fluor Enterprises, a JV**OSM Departure Time:** 1530**Contractor:** American Bridge/Fluor Enterprises, a JV**Location:** Benicia, CA**CWI Name:** Michael Johnson**CWI Present:** Yes No**Inspected CWI report:** Yes No N/A**Rod Oven in Use:** Yes No N/A**Electrode to specification:** Yes No N/A**Weld Procedures Followed:** Yes No N/A**Qualified Welders:** Yes No N/A**Verified Joint Fit-up:** Yes No N/A**Approved Drawings:** Yes No N/A**Approved WPS:** Yes No N/A**Delayed / Cancelled:** Yes No N/A**Bridge No:** 34-0006**Component:** Procedure Qualification Record (PQR) Test**Summary of Items Observed:**

WELDING INSPECTION REPORT

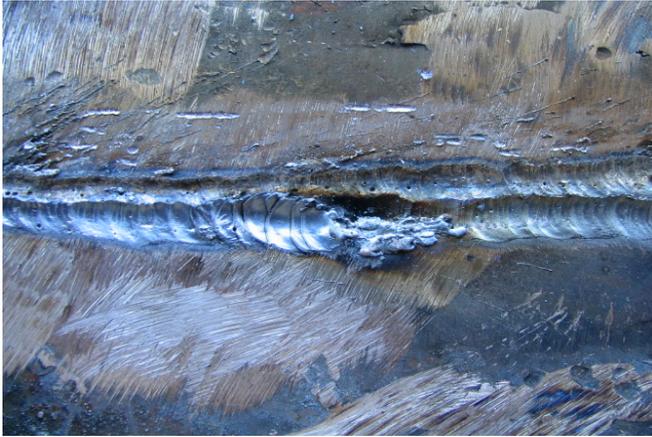
The QA Inspector observed the backing bar was removed by the welders on (3) PQR plates known as ABF-PQR-011-1C, ABF-PQR-025-1A and ABF-PQR-027-2. These PQR test plates failed Radiographic Testing (RT) because of excessive porosity. The QA Inspector examined the plates mentioned above and determined that porosity was visible on all the plates mentioned above. See the (left) example photo of ABF-PQR-027-2 for additional information.

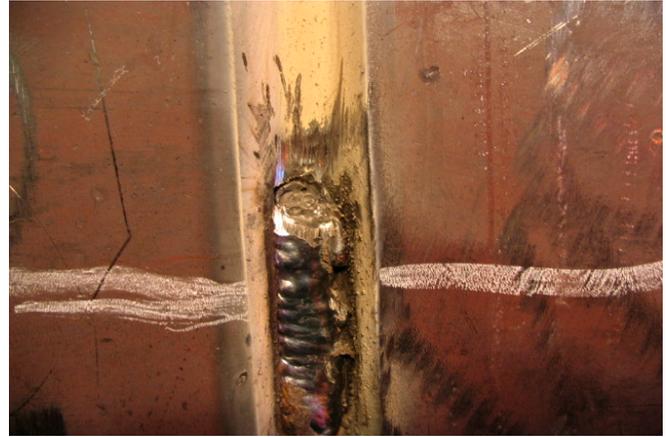
The QA Inspector observed welding the third attempt to weld PQR test plate known as ABF-PQR-002-2B. Welder Dan Gordon completed weld pass number 2 after several starts and stops. These starts and stops occurred at approximately 370 millimeters from the bottom of the plate and the QA Inspector was informed that the welders are having problems with the wire. See the photo on the right for additional information. Mr. Johnson monitored welding amperage, voltage and travel speed parameters. This PQR plate is being welded in the 3G position. The welders are using .072 inch diameter (1.8mm) Lincoln 232 E71T-8 (FCAW-S) process and utilizing a Bug-O Systems mechanical device that travels on a magnetic track. For specific welding parameters recorded during this PQR see Caltrans Welding Witness Report, TL-6032 generated upon the completion of this PQR test plate.
