DEPARTMENT OF TRANSPORTATION

Contract #: 04-0120F4Cty: SF/ALA Rte: 80 PM: 13.2/13.9File #: 1.28**WELDING INSPECTION REPORT****Resident Engineer:** Pursell, Gary**Address:** 333 Burma Road**City:** Oakland, CA 94607**Report No:** WIR-000381**Date Inspected:** 24-Aug-2007**Project Name:** SAS Superstructure**OSM Arrival Time:** 700**Prime Contractor:** American Bridge/Fluor Enterprises, a JV**OSM Departure Time:** 1530**Contractor:** American Bridge/Fluor Enterprises, a JV**Location:** Benica, CA**CWI Name:** Michael Johnson**CWI Present:** Yes No**Inspected CWI report:** Yes No N/A**Rod Oven in Use:** Yes No N/A**Electrode to specification:** Yes No N/A**Weld Procedures Followed:** Yes No N/A**Qualified Welders:** Yes No N/A**Verified Joint Fit-up:** Yes No N/A**Approved Drawings:** Yes No N/A**Approved WPS:** Yes No N/A**Delayed / Cancelled:** Yes No N/A**Bridge No:** 34-0006**Component:** Procedure Qualification Record (PQR) Test**Summary of Items Observed:**

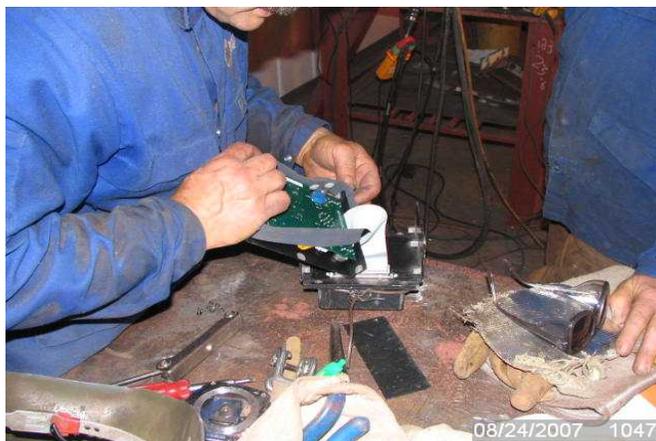
The QA Inspector observed that the welders are experiencing problems with the Bug-O device. It was observed that the welders have taken apart this device to make repairs. See the left photo below for additional information.

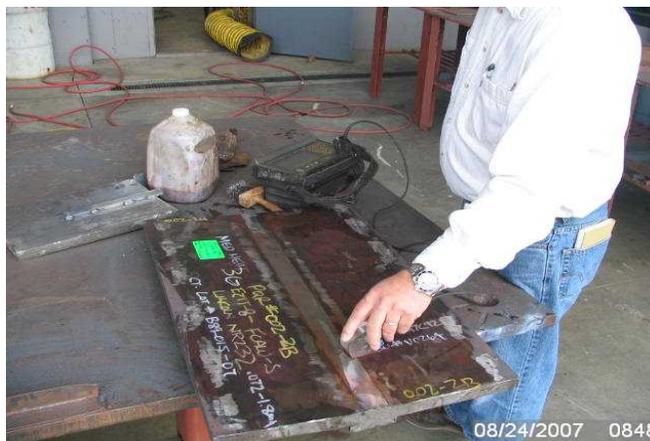
The QC Inspector informed the QA Inspector that he performed informational Ultrasonic Testing (UT) on the PQR plate known as ABF-PQR-002-2B and found several indications in the root area. See the right photo above for additional information. The QA Inspector was informed these indications would be considered acceptable and the QC Inspector informed ABF Representative Mr. Tommy Gibson of the indications found. The QA Inspector was informed by Mr. Gibson that this PQR plate will undergo Radiographic testing and was shipped this date.
