DEPARTMENT OF TRANSPORTATION

Contract #: 04-0120F4Cty: SF/ALA Rte: 80 PM: 13.2/13.9File #: 69.28**WELDING INSPECTION REPORT****Resident Engineer:** Pursell, Gary**Address:** 333 Burma Road**City:** Oakland, CA 94607**Report No:** WIR-000395**Date Inspected:** 28-Aug-2007**Project Name:** SAS Superstructure**OSM Arrival Time:** 1400**Prime Contractor:** American Bridge/Fluor Enterprises, a JV**OSM Departure Time:** 2230**Contractor:** Zhenhua Port Machinery Company, Ltd (ZPMC), Changxing Island **Location:** Shanghai, China**CWI Name:** Ye Yong Jun**CWI Present:** Yes No**Inspected CWI report:** Yes No N/A**Rod Oven in Use:** Yes No N/A**Electrode to specification:** Yes No N/A**Weld Procedures Followed:** Yes No N/A**Qualified Welders:** Yes No N/A**Verified Joint Fit-up:** Yes No N/A**Approved Drawings:** Yes No N/A**Approved WPS:** Yes No N/A**Delayed / Cancelled:** Yes No N/A**Bridge No:** 34-0006**Component:** Caltrans Mock-Up 77.00**Summary of Items Observed:**

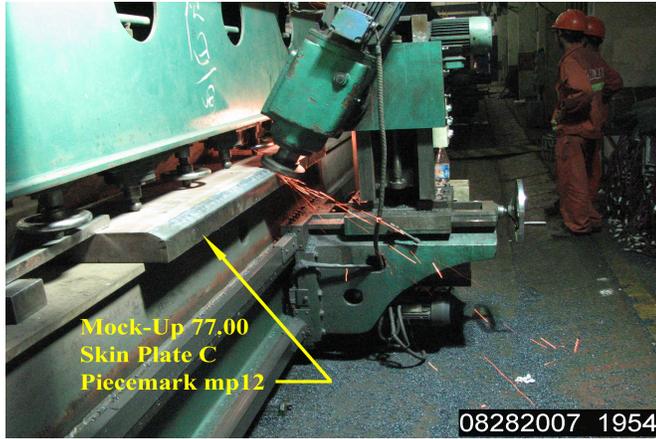
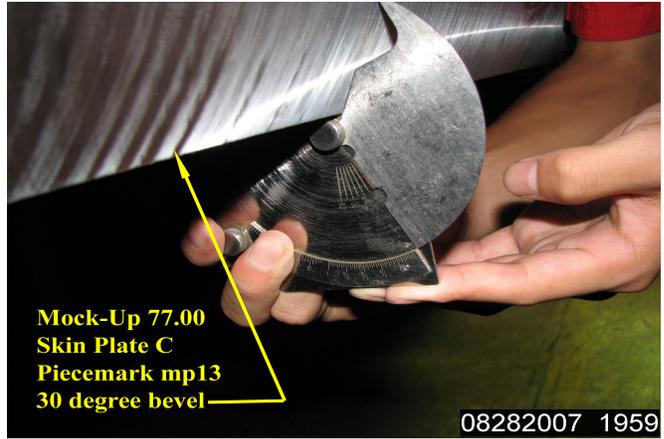
Caltrans QA Inspector observed ZPMC shop personnel performing the beveling on subassembly, Skin Plate C, perimeter plate edge. The beveling is being performed on the ZPMC milling machine. The skin plate subassembly is made-up of three plates (mp13, MA4, mp12) that have been welded together. The assembly is positioned with the inside side up on the mill machine table, then aligned and held in place clamps. ZPMC is observed in the process of milling the single 30 degree bevel for plate, piecemark mp12. The 30 degree bevel for piecemark mp 12 double bevels has been completed. It appeared that the 45 degree bevel for this plate has been flame cut. ZPMC QA inspector Mr. Lay Tao stated that this cut was a preliminary cut and that this flame cut bevel would be completed by milling the bevel to the finish bevel angle cut. Caltrans QA randomly verified the milling in process and completed bevel. The bevel surface finish, bevel angle and bevel off-set were in conformance with contract specifications. Following digital pictures illustrate machining in progress and completed bevel.

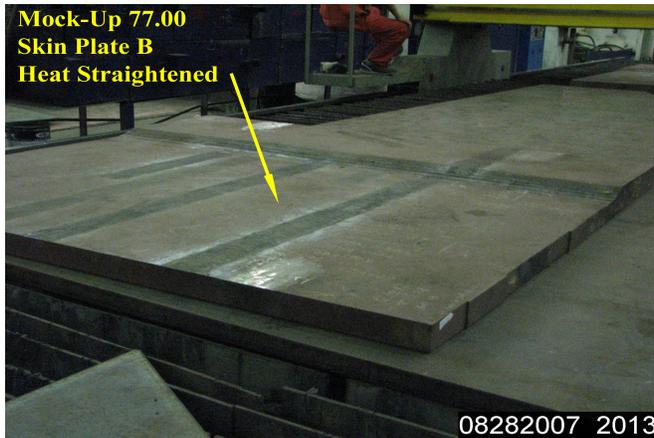
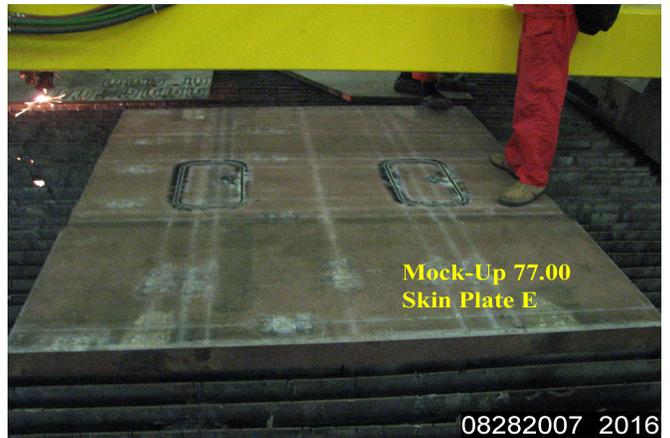
Caltrans QA Inspector questioned ZPMC QA inspector, Mr. Lay Tao in regards to the status and whereabouts of Skin Plate B, E and D. ZPMC QA stated that ZPMC has completed the heat straightening of skin plate B and is located at the burn table. ZPMC has completed the flame cutting of the two holes on Skin Plate E and is located at the burn table. Caltrans observed that no further work has been performed on either the assemblies and that it appears that ZPMC is in the process preparing Skin Plate D, for welding of the longitudinal stiffeners and is located at the front of the shop. Following digital pictures illustrates Skin Plate B and Skin Plate C.
