DEPARTMENT OF TRANSPORTATION

Contract #: 04-0120F4Cty: SF/ALA Rte: 80 PM: 13.2/13.9File #: 1.28**WELDING INSPECTION REPORT****Resident Engineer:** Pursell, Gary**Address:** 333 Burma Road**City:** Oakland, CA 94607**Report No:** WIR-000407**Date Inspected:** 04-Sep-2007**Project Name:** SAS Superstructure**OSM Arrival Time:** 700**Prime Contractor:** American Bridge/Fluor Enterprises, a JV**OSM Departure Time:** 1700**Contractor:** American Bridge/Fluor Enterprises, a JV**Location:** Benicia, CA**CWI Name:** Micheal Johnson**CWI Present:** Yes No**Inspected CWI report:** Yes No N/A**Rod Oven in Use:** Yes No N/A**Electrode to specification:** Yes No N/A**Weld Procedures Followed:** Yes No N/A**Qualified Welders:** Yes No N/A**Verified Joint Fit-up:** Yes No N/A**Approved Drawings:** Yes No N/A**Approved WPS:** Yes No N/A**Delayed / Cancelled:** Yes No N/A**Bridge No:** 34-0006**Component:** Procedure Qualification Record (PQR) Test**Summary of Items Observed:**

WELDING INSPECTION REPORT

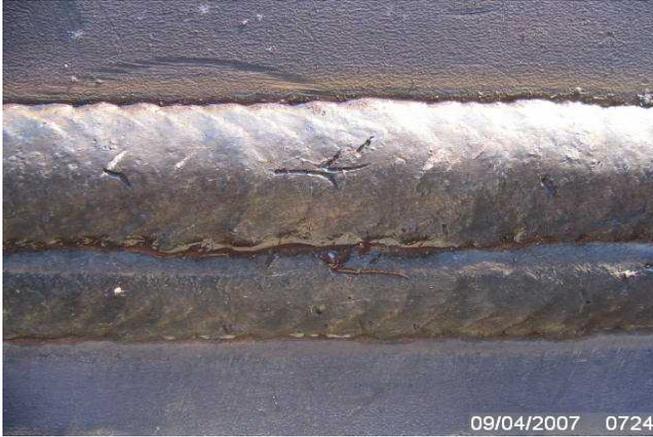
The QA Inspector observed the third attempt to weld PQR test plate known as ABF-PQR-010-2B. Welder Dan Gordon completed (10) total weld passes in the 1G position. Mr. Johnson monitored welding amperage, voltage and travel speed parameters. The welders are using .072 inch diameter (1.8mm) ESAB Coreshield-8 E71T-8 self shielding Flux Core Arc Welding (FCAW-S) process. It is noted that the root weld pass was deposited by hand and the (9) sequential weld passes were deposited utilizing a Bug-O Systems mechanical device that travels on a magnetic track. The QA Inspector observed that the cover weld passes number 9 and 10 appeared to contain very small round indications with trails. See photo below for additional information.

The QA Inspector observed that after grinding, the round indications appeared to have been removed. The QA Inspector observed that upon completion the QC Inspector performed Visual Testing (VT) and informational Ultrasonic Testing (UT). Following the QC Inspectors acceptance, The QA Inspector performed a VT inspection and affixed a green tag to the face of this PQR test plate. For specific welding parameters recorded during this PQR see Caltrans Welding Witness Report, TL-6032 generated upon the completion of this PQR test plate.
