Contract #: 04-0120F4Cty: SF/ALA Rte: 80 PM: 13.2/13.9File #: 1.28**WELDING INSPECTION REPORT****Resident Engineer:** Pursell, Gary**Address:** 333 Burma Road**City:** Oakland, CA 94607**Report No:** WIR-000409**Date Inspected:** 06-Sep-2007**Project Name:** SAS Superstructure**OSM Arrival Time:** 700**Prime Contractor:** American Bridge/Fluor Enterprises, a JV**OSM Departure Time:** 1700**Contractor:** American Bridge/Fluor Enterprises, a JV**Location:** Benicia, CA**CWI Name:** Michael Johnson**CWI Present:** Yes No**Inspected CWI report:** Yes No N/A**Rod Oven in Use:** Yes No N/A**Electrode to specification:** Yes No N/A**Weld Procedures Followed:** Yes No N/A**Qualified Welders:** Yes No N/A**Verified Joint Fit-up:** Yes No N/A**Approved Drawings:** Yes No N/A**Approved WPS:** Yes No N/A**Delayed / Cancelled:** Yes No N/A**Bridge No:** 34-0006**Component:** Procedure Qualification Record (PQR) Test**Summary of Items Observed:**

WELDING INSPECTION REPORT

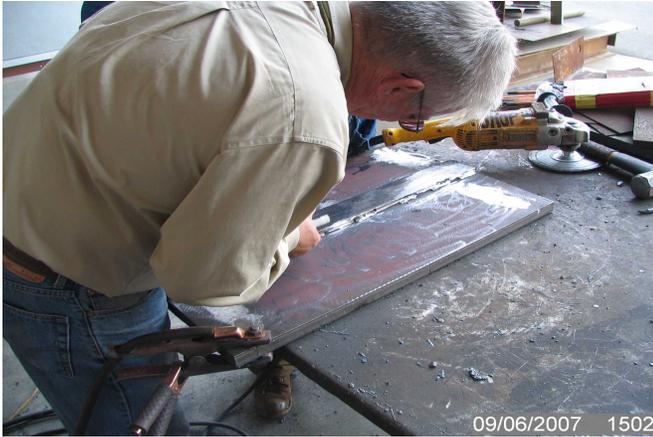
The QC Inspector informed the QA Inspector the PQR plate known as ABF-PQR-011-1D was ready for Visual Testing (VT) (see photo on the left below for additional information) and informational Ultrasonic Testing (UT) (see photo on the right for additional information). The QA Inspector observed the QC Inspector perform these inspections and upon the QC inspectors acceptance, the QA Inspector performed VT inspection. The QA Inspector observed that the weld reinforcement was not ground at this time and was informed that it would be ground prior to being shipped for Radiographic Testing.
