**DEPARTMENT OF TRANSPORTATION**

Contract #: 04-0120F4Cty: SF/ALA Rte: 80 PM: 13.2/13.9File #: 69.28**WELDING INSPECTION REPORT****Resident Engineer:** Pursell, Gary**Address:** 333 Burma Road**City:** Oakland, CA 94607**Report No:** WIR-000465**Date Inspected:** 12-Sep-2007**Project Name:** SAS Superstructure**OSM Arrival Time:** 900**Prime Contractor:** American Bridge/Fluor Enterprises, a JV**OSM Departure Time:** 1730**Contractor:** Zhenhua Port Machinery Company, Ltd (ZPMC), Changxing Island **Location:** Shanghai, China

**Bridge No:** 34-0006**Component:** Welder Performance Qualifications**Summary of Items Observed:**

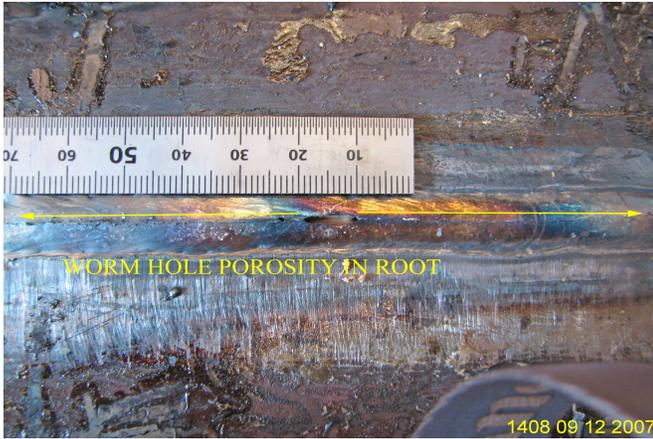
Caltrans Quality Assurance (QA) Inspector Charlie Franco was present at the time requested to randomly observe welding being performed for welder qualification. The QA Inspector observed the Flux Cored Arc Welding (FCAW) Process being used in the 1G position with ceramic backing strips attached. The QA Inspector observed several welders placing root passes in their test pieces utilizing the above FCAW process with ZPMC approved weld procedure specification WPS-B-T-2231-T. The QA Inspector observed QA/QC Engineer Jiang Weifeng of 3rd party inspection agency Moody International, inspecting the root passes of the test pieces. Mr. Weifeng rejected 4 of the test samples for cracks in the face side of the root passes and a 5th test piece because of worm hole porosity throughout the entire length of the root side of the root pass. There had been a total of 28 root passes placed at the time the 5th test piece was rejected for a failed root pass. The welders who had not failed the root pass inspection by Mr. Weifeng, were either continuing to weld or had completed welding their test pieces. The attached photograph provides additional detail of the test piece with the worm hole porosity.
