Contract #: 04-0120F4Cty: SF/ALA Rte: 80 PM: 13.2/13.9File #: 69.28**WELDING INSPECTION REPORT****Resident Engineer:** Pursell, Gary**Address:** 333 Burma Road**City:** Oakland, CA 94607**Report No:** WIR-000469**Date Inspected:** 10-Sep-2007**Project Name:** SAS Superstructure**OSM Arrival Time:** 630**Prime Contractor:** American Bridge/Fluor Enterprises, a JV**OSM Departure Time:** 1530**Contractor:** Zhenhua Port Machinery Company, Ltd (ZPMC), Changxing Island **Location:** Shanghai, China**CWI Name:** Wang Nan**CWI Present:** Yes No**Inspected CWI report:** Yes No N/A**Rod Oven in Use:** Yes No N/A**Electrode to specification:** Yes No N/A**Weld Procedures Followed:** Yes No N/A**Qualified Welders:** Yes No N/A**Verified Joint Fit-up:** Yes No N/A**Approved Drawings:** Yes No N/A**Approved WPS:** Yes No N/A**Delayed / Cancelled:** Yes No N/A**Bridge No:** 34-0006**Component:** Mock Up Assemblies-77M, 89M and 114M**Summary of Items Observed:**

Tower Mock-up for 89 Meters Elevation

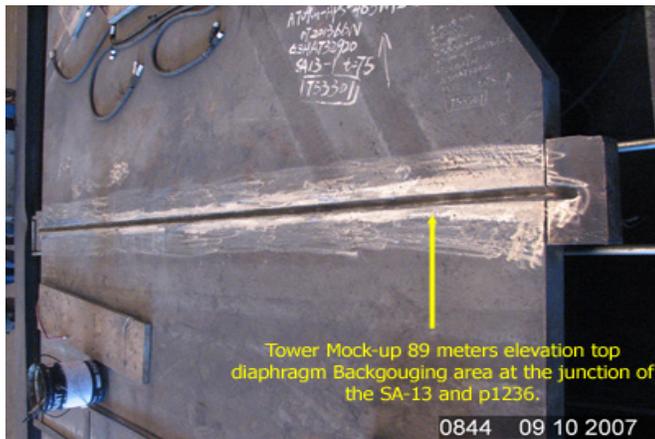
QA inspector performed visual inspection of the backgouged area at the junction of P1235 to the p213 after ZPMC ground the groove to bright metal. Due to the observed backgouged area profile relative to the requirements of the joint detail in figure 2.4 of AWS D1.5, the QA inspector requested to ABF representative Kevin Dye and ZPMC representative Li Xiu Yang as to how Quality Control performs verification of the groove profile as per contract documents. ZPMC representatives relayed that there were no dimensional requirements specified in AWS D1.5 2002. The QA inspector showed the applicable sections of the code. ZPMC and ABF representatives agreed that backgouged area needed to comply with figure 2.4. ABF relayed to the QA inspector that even though that ZPMC appeared to comply with dimensional requirements, ABF was going to recommend to ZPMC to make a template for them to use to verify the minimum radius and included angles of the gouged area. At the end of the shift, ZPMC was still grinding the backgouged groove area.
