DEPARTMENT OF TRANSPORTATION

Contract #: 04-0120F4Cty: SF/ALA Rte: 80 PM: 13.2/13.9File #: 69.28**WELDING INSPECTION REPORT****Resident Engineer:** Pursell, Gary**Address:** 333 Burma Road**City:** Oakland, CA 94607**Report No:** WIR-000477**Date Inspected:** 11-Sep-2007**Project Name:** SAS Superstructure**OSM Arrival Time:** 2330**Prime Contractor:** American Bridge/Fluor Enterprises, a JV**OSM Departure Time:** 800**Contractor:** Zhenhua Port Machinery Company, Ltd (ZPMC), Changxing Island **Location:** Shanghai, China

WELDING INSPECTION REPORT

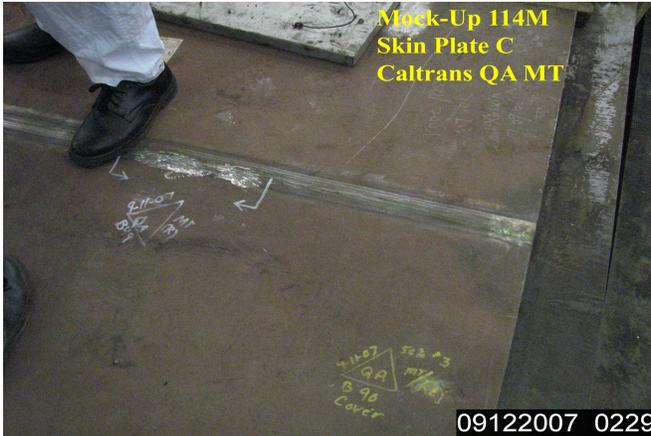
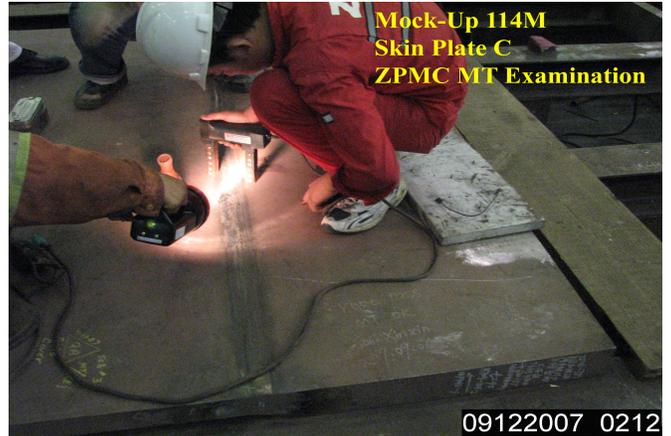
Item	Description	WBS	Dwg No.	Status
1	Mock-Up 114M	NA	NA	Work In Progress
	Mock-Up 114M, Skin Plate C (lower section): Caltrans QA Inspector witnessed ZPMC QC perform Magnetic Particle Test (MT) and Visual Test (VT) on weld cover pass MUSC-MA111-3, plate piecemark mp1018-1 to MA111-1, This weld had been previously MT'd and found to be non-compliant by Caltrans QA Inspector, Mr. David Smith. Mr. Smith identified two locations at the cover pass weld for rework. The locations were identified as 502mm to 504mm and 603mm to 700.5mm. ZPMC, QC, NDT technician is identified as, Mr. Cai Xin Xin. The test appeared to be in general conformance with AWS D1.5 2002 requirements. Caltrans QA Inspector performed MT at the locations, as mentioned above. See Caltrans Magnetic Particle Test Report, TL6028, generated on this date for additional information. The following digital pictures illustrate ZPMC MT in progress and Caltrans QA Inspector's inspection symbol, identifying the inspection of the weld.

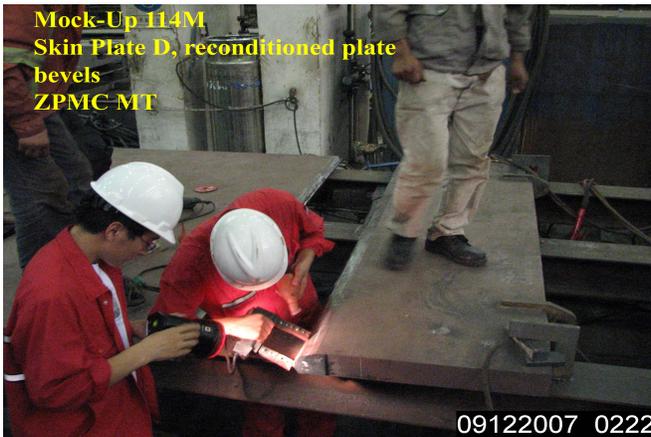
2 Mock-Up 114M, Skin Plate D NA NA ZPMC MT

Mock-Up 114M, Skin Plate D (CWR001) lower section: ZPMC QA inspector, Mr. Fu Yu hong reported that ZPMC would be performing MT in regards to the CWR001. Mr. Fu Yu hong stated that skin plates had been previously fitup and tack welded together. ZPMC observed crack tack welds. All welds were then removed and the bevels were reconditioned. Caltrans QA Inspector witnessed ZPMC QC perform, Magnetic Particle Test (MT) and Visual Test (VT) of the reconditioned bevels. ZPMC, QC, NDT technician is identified as, Mr. Cai Xin Xin. The test appeared to be in general conformance with AWS D1.5 2002 requirements. At the completion of the testing, ZPMC reported that no relevant indications observed. Following digital picture illustrates MT in progress.
