DEPARTMENT OF TRANSPORTATION

Contract #: 04-0120F4Cty: SF/ALA Rte: 80 PM: 13.2/13.9File #: 69.28**WELDING INSPECTION REPORT****Resident Engineer:** Pursell, Gary**Address:** 333 Burma Road**City:** Oakland, CA 94607**Report No:** WIR-000518**Date Inspected:** 12-Sep-2007**Project Name:** SAS Superstructure**OSM Arrival Time:** 630**Prime Contractor:** American Bridge/Fluor Enterprises, a JV**OSM Departure Time:** 1530**Contractor:** Zhenhua Port Machinery Company, Ltd (ZPMC), Changxing Island **Location:** Shanghai, China**CWI Name:** Lu Jian Ping**CWI Present:** Yes No**Inspected CWI report:** Yes No N/A**Rod Oven in Use:** Yes No N/A**Electrode to specification:** Yes No N/A**Weld Procedures Followed:** Yes No N/A**Qualified Welders:** Yes No N/A**Verified Joint Fit-up:** Yes No N/A**Approved Drawings:** Yes No N/A**Approved WPS:** Yes No N/A**Delayed / Cancelled:** Yes No N/A**Bridge No:** 34-0006**Component:** Tower Mock-Up for 77M and 114M**Summary of Items Observed:**

Tower Mock-up 77 Meter Elevation.

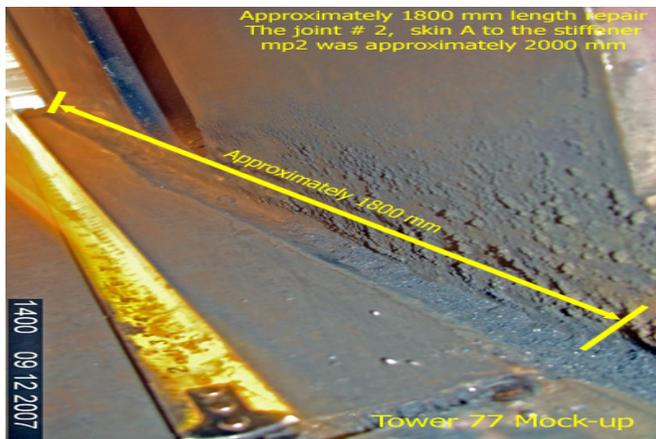
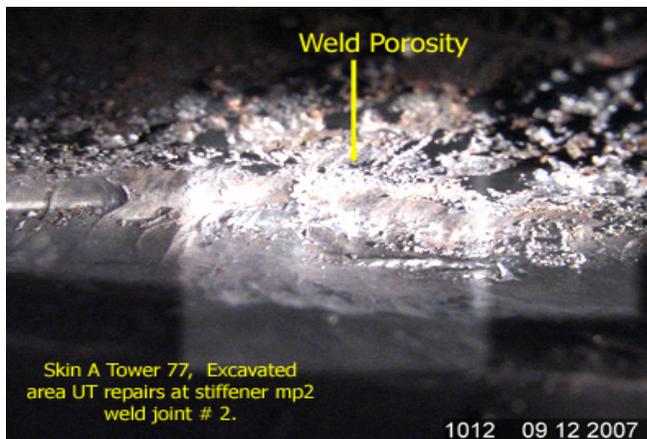
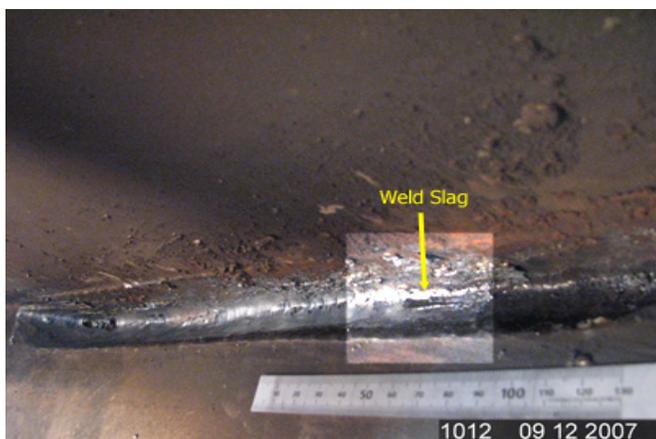
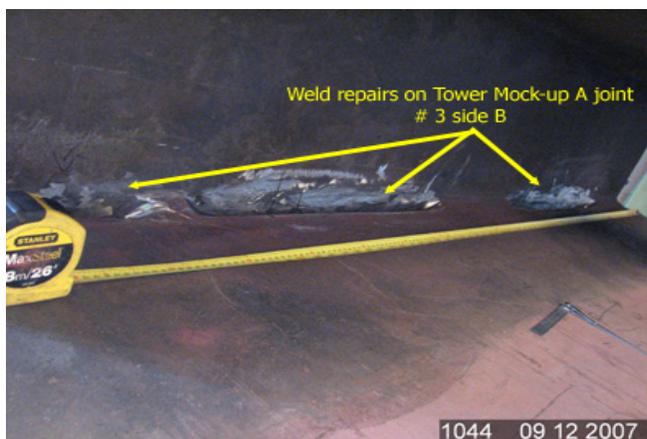
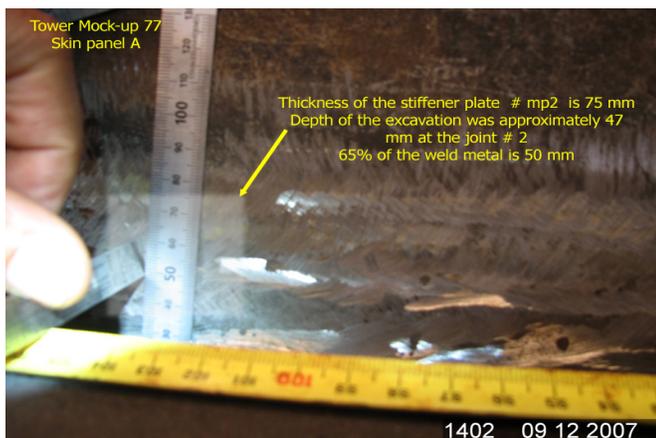
The QA inspector observed ZPMC performing air carbon arc gouging operations on the ultrasonically tested (UT) repair areas located at the junction of the skin A and E to the longitudinal stiffeners. The photos below show some of the locations; depth and length after backgouging operations.

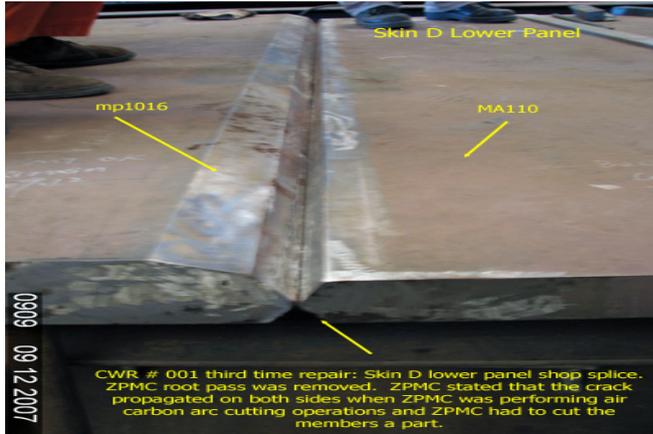
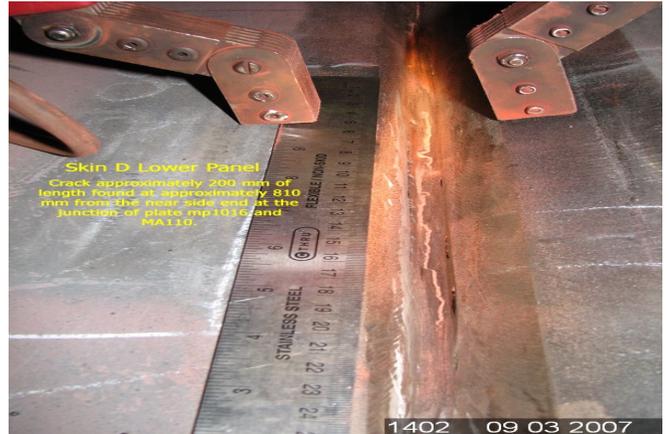
Item	Description	WBS	Dwg No.	Status
1	<p>Critical Weld repair (CWR) # 001 Tower Splice Mock-up 114 Meter Elevation.</p> <p>The QA inspector had a conversation with ZPMC QC Inspector Xu Bing. The QA inspector asked Mr. Xu why ZPMC removed the root pass completely in lieu of 200 mm as shown on the CWR-001. Mr. Xu relayed to the QA inspector that ZPMC asked ABF and ABF agreed with ZPMC to remove the weld completely. The QA inspector had a conversation with ABF representative Craig Knops. Mr. Knops relayed that it could be a misunderstanding, ABF did not agree to remove the root pass completely. The QA inspector had a conversation with QA representative Lu Jian Hua. Mr. Lu relayed to Mr. Knops, Caltrans Structure Representative Mr. Ryan Smith, ABF Representatives Mr.</p>

Peter Ferguson and Mr. Steve Lawton that ZPMC removed the root pass (2000 mm of length) because ZPMC chased the 200 mm crack and it propagated through the end of the joint. Mr. Lu added that according to the procedure listed on the CWR-001, ZPMC was allowed to remove the crack completely. The QA inspector relayed to Mr. Lu that the CWR # 001 did not reflect what ZPMC was planning to do after cutting the two plates apart. ABF, ZPMC and Caltrans agreed that the CWR# 001 needed to be revised and resubmitted to reflect what was actually performed.
