**DEPARTMENT OF TRANSPORTATION**

Contract #: 04-0120F4Cty: SF/ALA Rte: 80 PM: 13.2/13.9File #: 69.28**WELDING INSPECTION REPORT****Resident Engineer:** Pursell, Gary**Address:** 333 Burma Road**City:** Oakland, CA 94607**Report No:** WIR-000530**Date Inspected:** 24-Sep-2007**Project Name:** SAS Superstructure**OSM Arrival Time:** 630**Prime Contractor:** American Bridge/Fluor Enterprises, a JV**OSM Departure Time:** 1530**Contractor:** Zhenhua Port Machinery Company, Ltd (ZPMC), Changxing Island **Location:** Changxing Island**CWI Name:** Ye Jong Jun**CWI Present:** Yes No**Inspected CWI report:** Yes No N/A**Rod Oven in Use:** Yes No N/A**Electrode to specification:** Yes No N/A**Weld Procedures Followed:** Yes No N/A**Qualified Welders:** Yes No N/A**Verified Joint Fit-up:** Yes No N/A**Approved Drawings:** Yes No N/A**Approved WPS:** Yes No N/A**Delayed / Cancelled:** Yes No N/A**Bridge No:** 34-0006**Component:** 77m and 89m**Summary of Items Observed:**

Caltrans Quality Assurance (QA) Inspector, Larry Viars was present to observe the Ultrasonic Testing (UT) of the Caltrans Mock-up #89.00 and # 77.00, for the San Francisco Oakland Bay Self Anchored Suspension Bridge, at Zhen

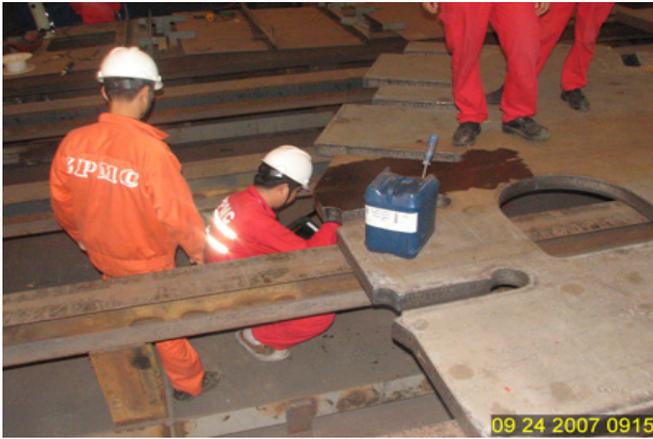
Caltrans QA Inspector observed ZPMC QC nondestructive technicians, Mr. Li Liming performing Ultrasonic Testing on Mock-up # 89.00 and # 77.00. The following picture below illustrates Mr. Li Miming performing Ultrasonic testing of # 77.00 diaphragm. Mr. Li Liming performed straight beam 45 degree and 70 degree shear wave testing of the items listed below. #77.00 Mock- up diaphragm MUB- MA21 weld # 67 and 89.00 diaphragm MUB1 weld # 60. Mock-up 77.00 base metal repair area. Welds tested on 89.00 diaphragms were adjacent to areas that slots were cut on the plate after the initial weld. The areas tested measured 1000 mm from each end of the weld. ZPMC QC Mr. Li Liming reported the above mentioned welds to be acceptable to AWS D1.5 requirements. Caltrans QA inspector Viars observed a random repair area on Mock-up 114.00 Skin A sub assembly MA107 weld # 3 that measured 200 mm. ZPMC QC Ye Yong Jun informed Clatrans QA that the repair was requested by Mr. Jun for weld profile irregularities noted on the weld. Mr. Jun informed Caltrans QA that WPS-345-SMAW-2G (2F) was utilized.

The Caltrans QA Inspector monitored Ultrasonic examinations of Mock-up # 77.00 and #89.00. QA Inspector observed that the testing appeared to be in general conformance with AWS D1.5 2002 requirements.
