Contract #: 04-0120F4Cty: SF/ALA Rte: 80 PM: 13.2/13.9File #: 1.28**WELDING INSPECTION REPORT****Resident Engineer:** Pursell, Gary**Address:** 333 Burma Road**City:** Oakland, CA 94607**Report No:** WIR-000544**Date Inspected:** 27-Sep-2007**Project Name:** SAS Superstructure**OSM Arrival Time:** 700**Prime Contractor:** American Bridge/Fluor Enterprises, a JV**OSM Departure Time:** 1700**Contractor:** American Bridge/Fluor Enterprises, a JV**Location:** Benica, CA**CWI Name:** Michael Johnson**CWI Present:** Yes No**Inspected CWI report:** Yes No N/A**Rod Oven in Use:** Yes No N/A**Electrode to specification:** Yes No N/A**Weld Procedures Followed:** Yes No N/A**Qualified Welders:** Yes No N/A**Verified Joint Fit-up:** Yes No N/A**Approved Drawings:** Yes No N/A**Approved WPS:** Yes No N/A**Delayed / Cancelled:** Yes No N/A**Bridge No:** 34-0006**Component:** Procedure Qualification Record (PQR) Test**Summary of Items Observed:**

WELDING INSPECTION REPORT

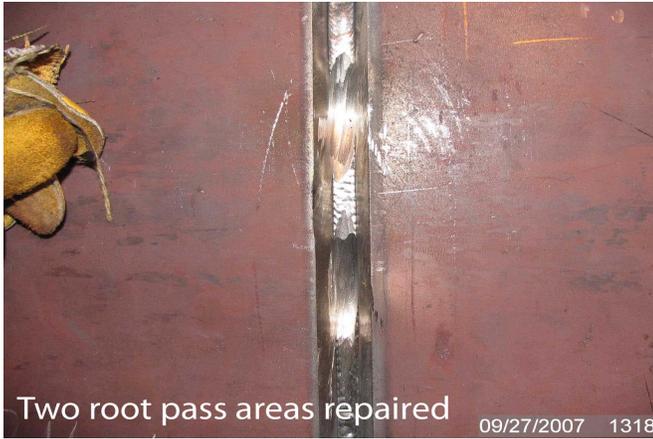
At the beginning of the shift the QA Inspector observed the welding operators deposit (10) weld passes onto the PQR test plate known as ABF-PQR-014-1C-CR in the 3G position. The welders are using 1/16 inch diameter (1.6mm) ESAB Dual Shield 70 Ultra Plus E71T-1M/9-M (FCAW-G) welding wire and 90% Argon / 10% Carbon Dioxide gas. Welder Dan Gordon deposited (10) sequential weld passes utilizing a Bug-O Systems mechanical device that travels on a magnetic track. Mr. Johnson and the QA Inspector monitored welding amperage, voltage and travel speed parameters. The QA Inspector was informed by the welders that (2) areas (each approximately 50 millimeters in length) in the root pass at approximately 550 millimeters and 640 millimeters from the start of the weld exhibited arc blow and were removed by grinding prior to repair. See photo below for additional information. For specific welding parameters recorded during this PQR see Caltrans Welding Witness Report, TL-6032 generated this date.
