**DEPARTMENT OF TRANSPORTATION**

Contract #: 04-0120F4Cty: SF/ALA Rte: 80 PM: 13.2/13.9File #: 69.28**WELDING INSPECTION REPORT****Resident Engineer:** Pursell, Gary**Address:** 333 Burma Road**City:** Oakland, CA 94607**Report No:** WIR-000566**Date Inspected:** 02-Oct-2007**Project Name:** SAS Superstructure**OSM Arrival Time:** 630**Prime Contractor:** American Bridge/Fluor Enterprises, a JV**OSM Departure Time:** 1530**Contractor:** Zhenhua Port Machinery Company, Ltd (ZPMC), Changxing Island **Location:** Shanghai, China**CWI Name:** Fu Yu Hong**CWI Present:** Yes No**Inspected CWI report:** Yes No N/A**Rod Oven in Use:** Yes No N/A**Electrode to specification:** Yes No N/A**Weld Procedures Followed:** Yes No N/A**Qualified Welders:** Yes No N/A**Verified Joint Fit-up:** Yes No N/A**Approved Drawings:** Yes No N/A**Approved WPS:** Yes No N/A**Delayed / Cancelled:** Yes No N/A**Bridge No:** 34-0006**Component:** Tower Mock-up 114**Summary of Items Observed:**

# WELDING INSPECTION REPORT

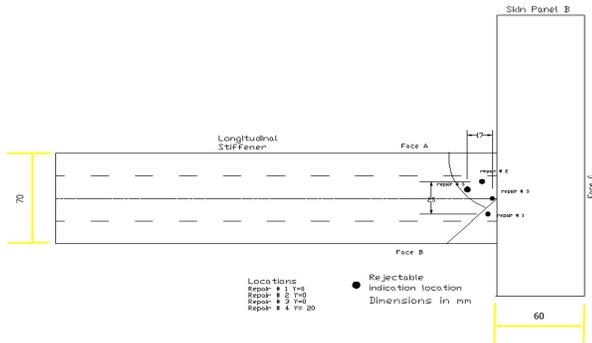
The QA inspector reviewed the ZPMC's ultrasonic test (UT) reports for the skin B upper level. The skin B, weld joint # 8 had rejectable indications located at the same general location Y value 0. These indications were repaired three times on the same general area. After the third repair, ZPMC found a rejectable indication at the same general location. See sketch below shown with the approximate location of the rejectable indications reported on ZPMC's UT reports. The QA inspector had a conversation with the ZPMC QA inspector Fu Yu Hong. Mr. Fu relayed to the QA inspector that because the separation between rejectable indications ZPMC was not considering the repairs were located at the same location. The QA inspector had a conversation with the Caltrans Task Leader Jim Cochran. The QA inspector brought to Mr. Cochran attention that ZPMC performed three times UT repairs and found a four repair at the same general location. After reviewing the locations of the rejectable indication on the ZPMC's UT reports, Mr. Cochran and Senior Task Leader Dave McClary relayed to the QA inspector that the Contractor failed to notify before ZPMC proceed with the third repair and a non conformance report (NCR) needed to be issue to address this condition.
