Contract #: 04-0120F4
 Cty: SF/ALA Rte: 80 PM: 13.2/13.9
 File #: 69.28

WELDING INSPECTION REPORT

Report No: WIR-000577
Date Inspected: 04-Oct-2007

Project Name: SAS Superstructure **OSM Arrival Time:** 630
Prime Contractor: American Bridge/Fluor Enterprises, a JV **OSM Departure Time:** 1530
Contractor: Zhenhua Port Machinery Company, Ltd (ZPMC), Changxing Island **Location:** Shanghai, China

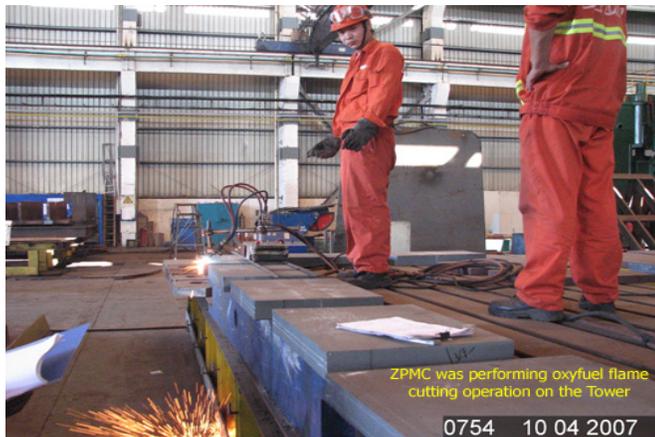
CALTRANS Quality Assurance (QA) Inspector, Alfredo Acuna was present for the fabrication of the Mock-up 77, 89 and 114 meters elevations scheduled for this project at the ZPMC facility in Shanghai, China for the San Francisco Oakland Bay Self Anchored Suspension Bridge.
 Tower 89 Meters Elevation.
 The QA inspector observed ZPMC performing oxyfuel gas cutting and machining (beveling) operations.
 See digital photograph below:

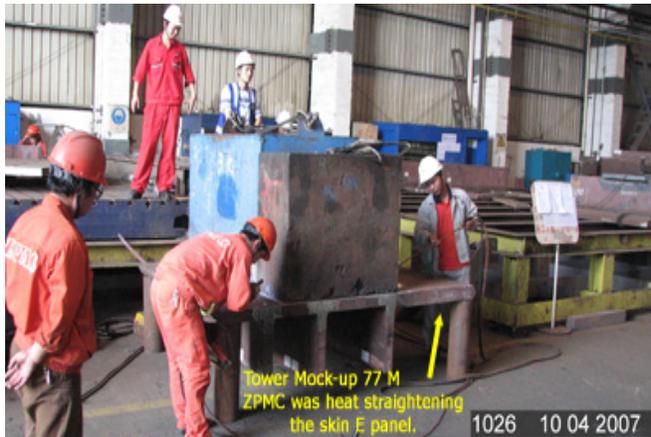
Tower Mock-up 77 Meter Elevation

The QA inspector observed ZPMC performing heat straightening operation at the skin plate E. See the photograph below.

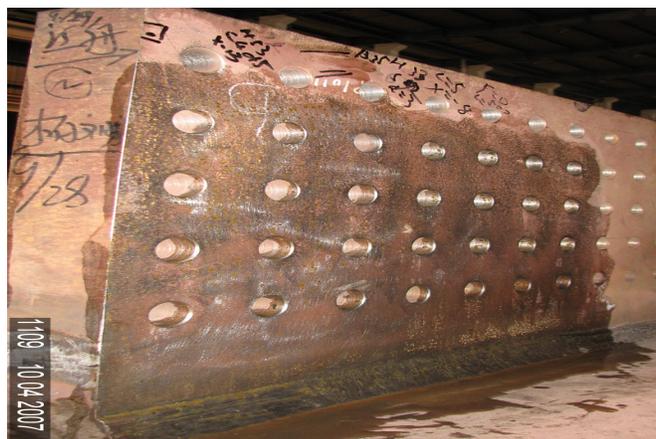
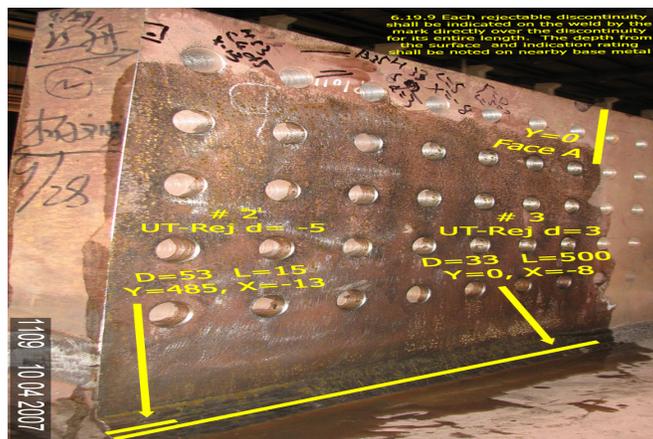
The QA inspector had a conversation with the Senior Level III John Kinsey. The QA inspector brought to his attention that ZPMC did not mark the location of the rejectable indications directly over the weld clearly with the depth and rating of the indication nearby, in addition the QA inspector relayed that the QA inspector had mentioned before to ABF and ZPMC representatives in several occasions. Mr. Kinsey relayed to the QA inspector that he would bring these issues in the ABF, ZPMC and Caltrans meeting.

The photographs below show on the left side ZPMC's actual marking and on the right side the required marking (directly on the weld) as per AWS D1.5 (2002).
