DEPARTMENT OF TRANSPORTATION

Contract #: 04-0120F4Cty: SF/ALA Rte: 80 PM: 13.2/13.9File #: 69.28**WELDING INSPECTION REPORT****Resident Engineer:** Pursell, Gary**Address:** 333 Burma Road**City:** Oakland, CA 94607**Report No:** WIR-000586**Date Inspected:** 04-Oct-2007**Project Name:** SAS Superstructure**OSM Arrival Time:** 1400**Prime Contractor:** American Bridge/Fluor Enterprises, a JV**OSM Departure Time:** 2300**Contractor:** Zhenhua Port Machinery Company, Ltd (ZPMC), Changxing Island **Location:** Changxing Island**CWI Name:** Hau Li Wei**CWI Present:** Yes No**Inspected CWI report:** Yes No N/A**Rod Oven in Use:** Yes No N/A**Electrode to specification:** Yes No N/A**Weld Procedures Followed:** Yes No N/A**Qualified Welders:** Yes No N/A**Verified Joint Fit-up:** Yes No N/A**Approved Drawings:** Yes No N/A**Approved WPS:** Yes No N/A**Delayed / Cancelled:** Yes No N/A**Bridge No:** 34-0006**Component:** 77 D & 114 A,C**Summary of Items Observed:**

WELDING INSPECTION REPORT

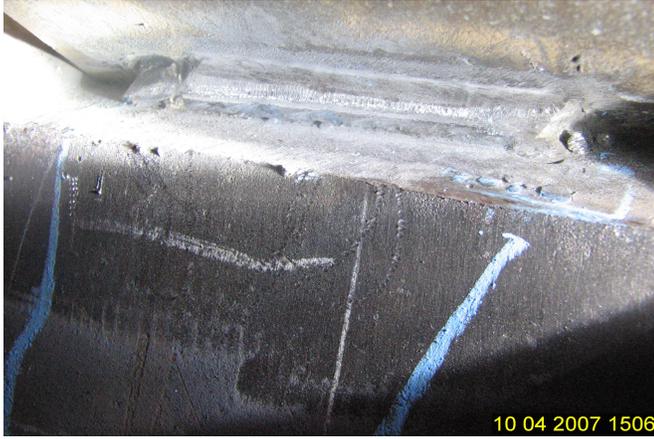
Caltrans QA Inspector requested Bureau Veritas QC Mr. Hau Li Wei to perform visual inspection of Mock-up # 77.00 connection plate tack welds. Mr. Hau Li Wei stated that the tack welds were not in conformance with AWS D1.5 requirements. Numerous areas of weld spatter, overlap, areas at the ends of tack welds were not transitioned. The following picture illustrates tack welds prior to repair. Mr. Wei requested the areas be repaired and Magnetic Particle Testing be performed.
