DEPARTMENT OF TRANSPORTATION

Contract #: 04-0120F4Cty: SF/ALA Rte: 80 PM: 13.2/13.9File #: 69.28**WELDING INSPECTION REPORT****Resident Engineer:** Pursell, Gary**Address:** 333 Burma Road**City:** Oakland, CA 94607**Report No:** WIR-000618**Date Inspected:** 09-Oct-2007**Project Name:** SAS Superstructure**OSM Arrival Time:** 630**Prime Contractor:** American Bridge/Fluor Enterprises, a JV**OSM Departure Time:** 1530**Contractor:** Zhenhua Port Machinery Company, Ltd (ZPMC), Changxing Island **Location:** Shanghai, China**CWI Name:** Hu Gang**CWI Present:** Yes No**Inspected CWI report:** Yes No N/A**Rod Oven in Use:** Yes No N/A**Electrode to specification:** Yes No N/A**Weld Procedures Followed:** Yes No N/A**Qualified Welders:** Yes No N/A**Verified Joint Fit-up:** Yes No N/A**Approved Drawings:** Yes No N/A**Approved WPS:** Yes No N/A**Delayed / Cancelled:** Yes No N/A**Bridge No:** 34-0006**Component:** Tower Mock-up 114 M and 89 M**Summary of Items Observed:**

Tower Splice Mock-up 114 Meter Elevation

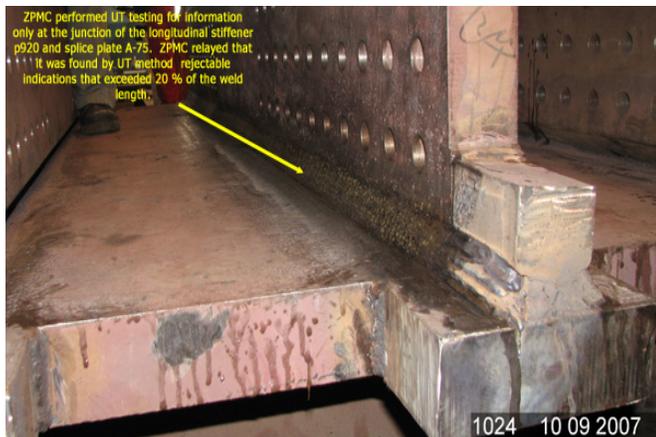
The QA inspector observed that the weld joint # 3 at the junction of internal splice A-75 to the longitudinal stiffener, had couplant residues from the ultrasonic testing (UT) and that there were no marks indicating the final results from the test as to whether or not the weld was acceptable or rejectable (this weld joint was welded by one of the ZPMC best welders because ZPMC was searching for the causes of the high UT rejection rate on the stiffeners connections). The QA inspector had conversation with ABF on site representative Mr. Steve Lawton. The QA inspector questioned Mr. Steve Lawton about the results of the UT performed by ZPMC at the junction of internal splice A-75 to the longitudinal stiffener, weld joint # 3. After Mr. Steve Lawton conversed with ZPMC QA representative Mr. Hu Gang, Mr. Lawton relayed to the QA inspector that the weld joint # 3 at the junction of the internal splice A-75 and longitudinal stiffener had over 20 % of rejectable indications on the weld joint as detected by ZPMC's UT. The QA inspector brought this matter to the attention of Senior Task Leader Mr. David McClary about the results of the UT examination on the internal splice A-75. The photograph below shows the joint # 3, at the internal splice A-75.
