**DEPARTMENT OF TRANSPORTATION**

Contract #: 04-0120F4Cty: SF/ALA Rte: 80 PM: 13.2/13.9File #: 69.28**WELDING INSPECTION REPORT****Resident Engineer:** Pursell, Gary**Address:** 333 Burma Road**City:** Oakland, CA 94607**Report No:** WIR-000619**Date Inspected:** 26-Sep-2007**Project Name:** SAS Superstructure**OSM Arrival Time:** 630**Prime Contractor:** American Bridge/Fluor Enterprises, a JV**OSM Departure Time:** 1530**Contractor:** Zhenhua Port Machinery Company, Ltd (ZPMC), Changxing Island **Location:** Shanghai, China**CWI Name:** Ye YongJun**CWI Present:** Yes No**Inspected CWI report:** Yes No N/A**Rod Oven in Use:** Yes No N/A**Electrode to specification:** Yes No N/A**Weld Procedures Followed:** Yes No N/A**Qualified Welders:** Yes No N/A**Verified Joint Fit-up:** Yes No N/A**Approved Drawings:** Yes No N/A**Approved WPS:** Yes No N/A**Delayed / Cancelled:** Yes No N/A**Bridge No:** 34-0006**Component:** Tower Mock-up 77 and 114 M**Summary of Items Observed:**

**Tower Mock-up 77 Meter Elevation**

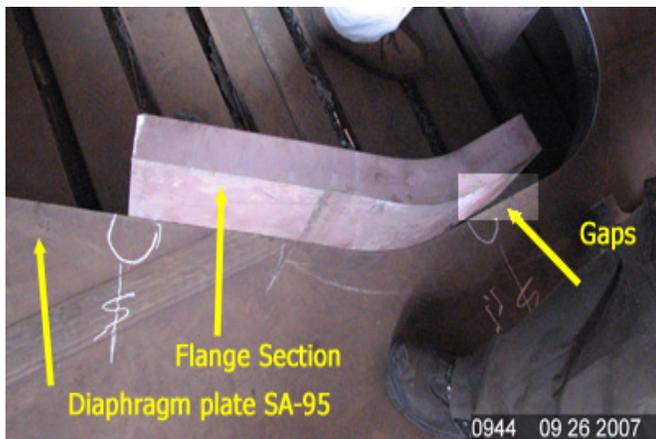
The QA inspector observed ZPMC pre-installing the flange sections (4 sections of 60 mm thick) to the lower diaphragm SA-95 opening. ZPMC was measuring the gaps between the four sections (individually) of the flange and the diaphragm's opening. The QA inspector had a conversation with the ZPMC QA inspector Shen Xue Jun. Mr. Shen relayed to the QA inspector that the bent flange sections did not meet the tolerance of the contract documents, and that the bent flange sections might be rejected by ZPMC. The photo below shows the member being fit-up to the opening.

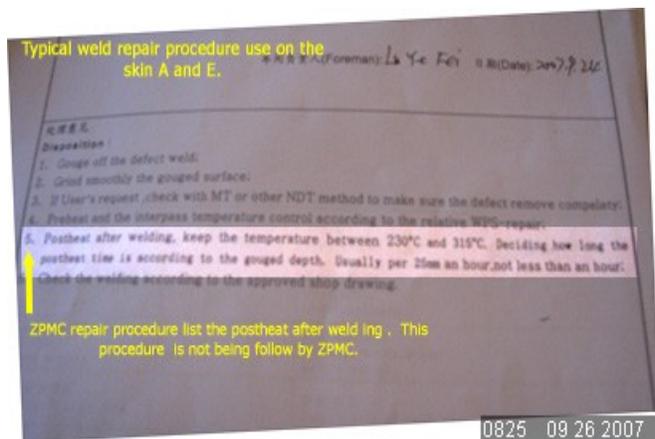
1	<p>Postheat after Repair Report Tower Mock-up 77 Meter Elevation</p> <p>The QA inspector observed that ZPMC was setting up to weld the Skin A and E for the Tower Mock-up 77. The QA inspector had a conversation with ZPMC QC inspector Xin Zhai Gu. The QA inspector asked the welding repair report pertinent for the skin plate A and E. After the QA inspector reviewed ZPMC's welding repair report, the QA inspector asked the QC inspector if ZPMC was performing postheat after welding on weld repairs according to the step # 5 of the repair procedure report. Mr. Xin relayed to the QA inspector that ZPMC did not intend performing postheat after welding and that ZPMC inadvertently wrote in the welding repair report the posheat after welding requirement. ZPMC QA Shen Xue Jun and Mr. Xin relayed to the QA inspector that ZPMC was following the approved WPS-345-SMAW-1G-Repair. The QA inspector brought it to the attention of ABF representative Mr. Jeff Evans that ZPMC had a weld repair report that ZPMC was not following. Mr. Evans relayed that ABF's position was that ZPMC needed to follow what was written in the welding repair report. The digital photograph below depicts the step # 5 of the welding repair report.</p>

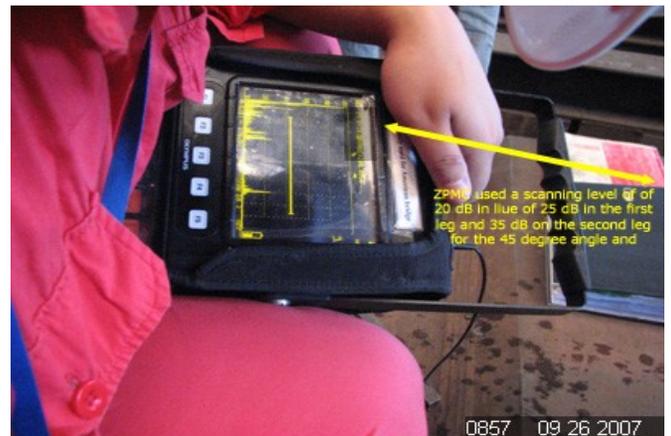
the probe-target technique calculating the angle beam from the projection on the center of the 50 mm plastic cylinder in lieu of checking the engraved mark on the block (ZPMC calibration IIW block type II, does not give the ability the inspector to measured 70 +/- 2 of the nominal angle. See digital photograph below taken on 09/17/07). In addition, the QA inspector observed that ZPMC UT operators were performing UT operations scanning lower level than the required in table 6.3 from the AWS D1.5.2002. The QA inspector had a conversation with ABF QA Manager Mr. Steve Lawton. The QA inspector voiced that ZPMC is using a UT technique that is not in the contract documents; in addition, the QA inspector relayed to Mr. Steve Lawton that Ms. E and Mr. Li were not scanning in accordance with the table 6.3 AWS D1.5 2002. Mr. Steve Lawton agreed with QA inspector that the scanning level needed to be performed as required within AWS D1.5 (2002). In addition, Mr. Steve Lawton met with ZPMC to discuss ZPMC scanning technique. Mr. Steve Lawton relayed to the QA inspector that ZPMC relayed to him that ZPMC was scanning in compliance with AWS D1.5 2002. Mr. Steve Lawton relayed that ABF was planning to give a training section to ZPMC about calibration and scanning technique per AWS D1.5. 2002. The photograph below shows Mr. Steve Lawton discussing and giving demonstrations about scanning techniques.
