**DEPARTMENT OF TRANSPORTATION**

Contract #: 04-0120F4Cty: SF/ALA Rte: 80 PM: 13.2/13.9File #: 69.28**WELDING INSPECTION REPORT****Resident Engineer:** Pursell, Gary**Address:** 333 Burma Road**City:** Oakland, CA 94607**Report No:** WIR-000642**Date Inspected:** 16-Oct-2007**Project Name:** SAS Superstructure**OSM Arrival Time:** 630**Prime Contractor:** American Bridge/Fluor Enterprises, a JV**OSM Departure Time:** 1500**Contractor:** Zhenhua Port Machinery Company, Ltd (ZPMC), Changxing Island **Location:** Shanghai, China**CWI Name:** Xu Bing**CWI Present:** Yes No**Inspected CWI report:** Yes No N/A**Rod Oven in Use:** Yes No N/A**Electrode to specification:** Yes No N/A**Weld Procedures Followed:** Yes No N/A**Qualified Welders:** Yes No N/A**Verified Joint Fit-up:** Yes No N/A**Approved Drawings:** Yes No N/A**Approved WPS:** Yes No N/A**Delayed / Cancelled:** Yes No N/A**Bridge No:** 34-0006**Component:** Caltrans Mockup**Summary of Items Observed:**

# WELDING INSPECTION REPORT

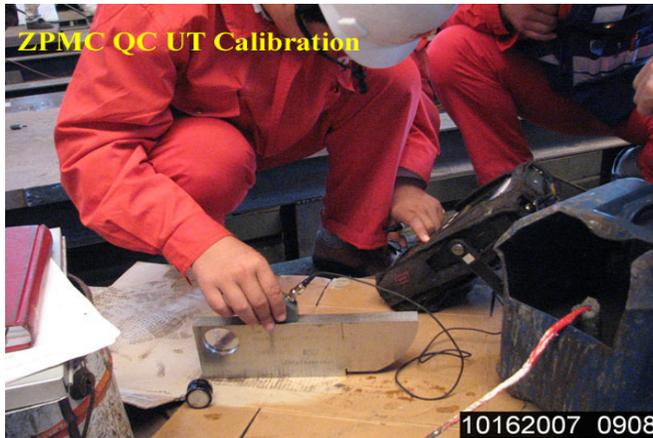
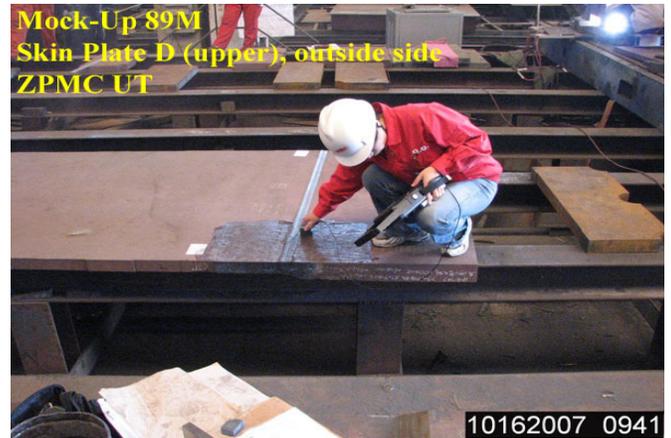
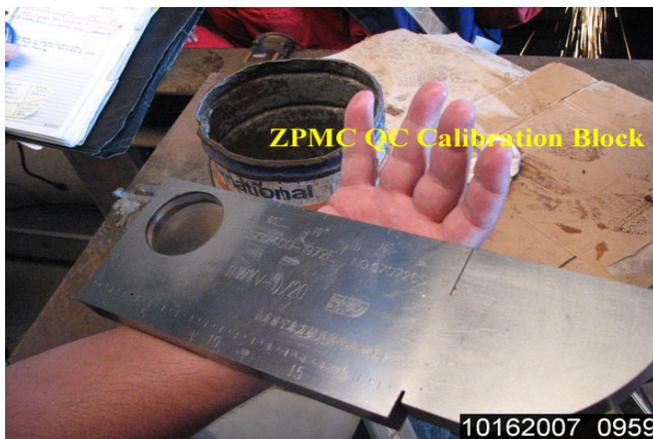
Mock-Up 89M, Skin Plate D (upper & lower); Caltrans QA Inspector observed ZPMC ultrasonic technicians Mr. Li Li Ming and Ms. E Shui Qin perform ultrasonic testing (UT) on skin plate splice welds, piecemark mp509 to mp513 and mp506 to MA22, inside/outside side, complete joint penetration butt welds. Caltrans QA Inspector observed that QC was not following the approved ultrasonic procedure in the WQCP. The calibration block that was used, does not show the 2 degree markings on either side for the major angles used (45, 60 and 70). See Caltrans Non-Conformance Report (NCR) TL-15, generated on this date for additional information. Following digital pictures illustrate UT calibration, calibration block used and ultrasonic testing in progress.
