**DEPARTMENT OF TRANSPORTATION**

Contract #: 04-0120F4Cty: SF/ALA Rte: 80 PM: 13.2/13.9File #: 69.28**WELDING INSPECTION REPORT****Resident Engineer:** Pursell, Gary**Address:** 333 Burma Road**City:** Oakland, CA 94607**Report No:** WIR-000649**Date Inspected:** 10-Oct-2007**Project Name:** SAS Superstructure**OSM Arrival Time:** 630**Prime Contractor:** American Bridge/Fluor Enterprises, a JV**OSM Departure Time:** 1730**Contractor:** Zhenhua Port Machinery Company, Ltd (ZPMC), Changxing Island **Location:** Shanghai, China**CWI Name:** Lu Jian Hua**CWI Present:** Yes No**Inspected CWI report:** Yes No N/A**Rod Oven in Use:** Yes No N/A**Electrode to specification:** Yes No N/A**Weld Procedures Followed:** Yes No N/A**Qualified Welders:** Yes No N/A**Verified Joint Fit-up:** Yes No N/A**Approved Drawings:** Yes No N/A**Approved WPS:** Yes No N/A**Delayed / Cancelled:** Yes No N/A**Bridge No:** 34-0006**Component:** Tower Mock-up 77, 89 and 114 & OBG**Summary of Items Observed:**

**Tower Splice Mock-up 114 Meter Elevation**

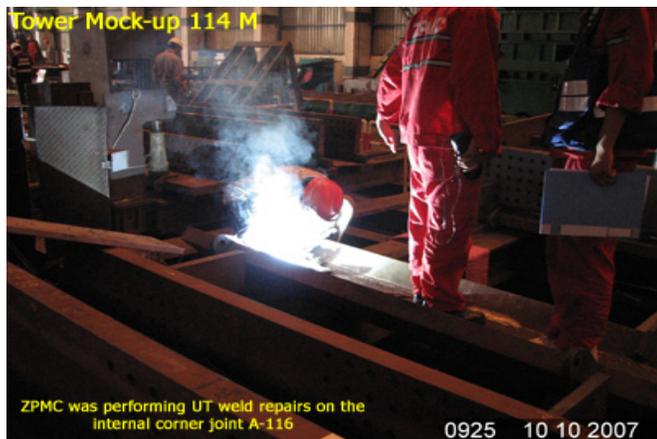
The QA inspector observed ZPMC performing weld repairs at the weld joint # 1 and 2, from the B side, at the internal corner plate A-116. The digital photo below shows ZPMC performing weld repairs at the above mentioned location.

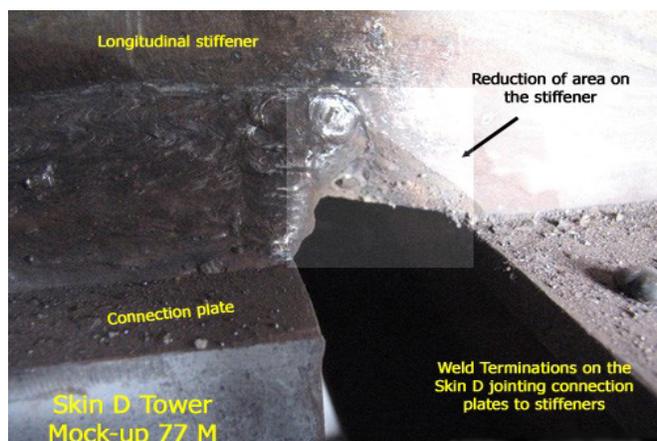
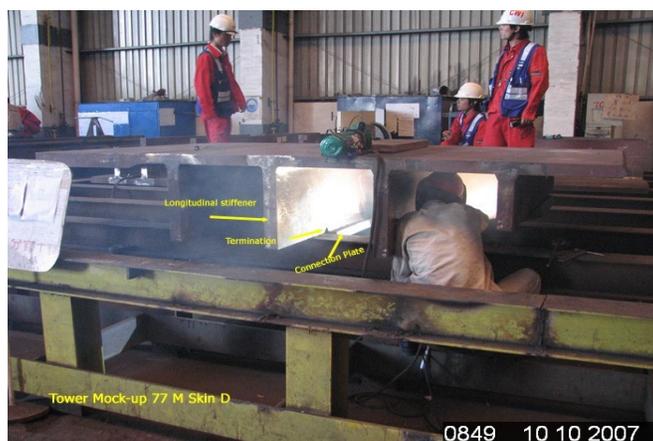
1	<p>Tower Mock-up 77 M Skin D, Weld terminations.</p> <p>The QA inspector had a conversation with ABF representative Mr. Chang Wei with Bureau of Veritas. The QA inspector asked Mr. Chang Wei regarding the terminations located at the junction of the connection plate and the longitudinal stiffeners at the Skin D. These weld terminations have small groove notches that are not indicated on the approved drawings. Prior to responding back to the QA inspector, Mr. Chang Wei discussed this issue with ZPMC representatives from the Technical Department. Mr. Chang Wei relayed to the QA inspector that the design drawings do not detail how ZPMC is required to terminate the joint and ZPMC technical department's position was that these terminations were acceptable. Mr. Chang Wei added that he would discuss the present conditions with ABF representatives. After, Mr. Chang Wei discussed with ABF Supervisor Mr. Kevin Carpenter. Mr. Kevin Carpenter relayed to him that he agreed with ZPMC; and that the condition of the termination were acceptable. The photographs below show the location of the termination after welded. Note: The terminations have not been ground.</p>

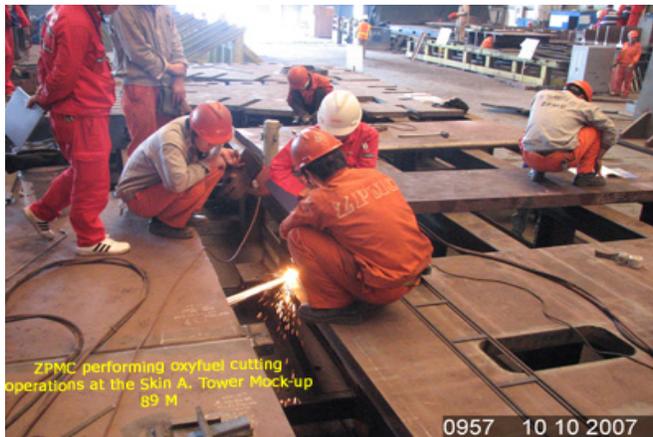
2	<p>Tower Mock-up 89 M</p> <p>The QA inspector observed ZPMC performing oxyfuel gas cutting operations at the skin A for the sub-assembly MA-21. See digital photograph below.</p> <p>ZPMC fabrication on the Tower Mock-up was observed as following:</p> <ul style="list-style-type: none"><li>Skin D Top shop splice was tack welded.</li><li>Skin C Top shop splices were completed welded</li><li>Skin C Lower shop splices, the welding was in progress.</li><li>Skin E rotation devices were being welded.</li></ul>			
---	--	--	--	--

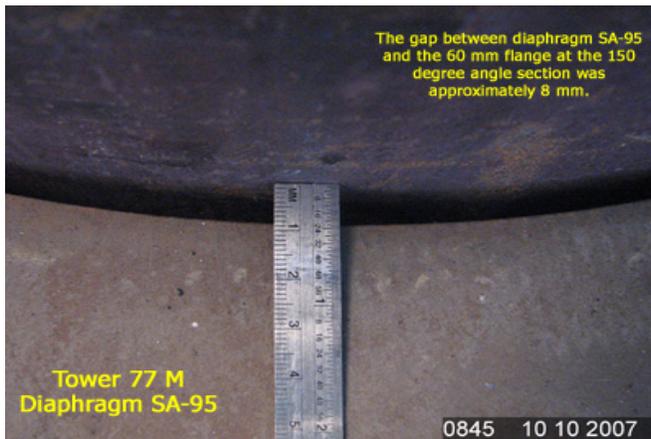
3 Tower Mock-up 77 M, Dimensional verifications Diaphragm SA-95 and Flanges SA-274

The QA inspector observed that 150 degrees bent flange section SA-273 and the 30 degrees bent flange piece marked p585. The QA inspector observed that the bent flange section p585 had a gap of approximately 3 mm and the bent section SA-273 had a gap of approximately 8 mm. The QA inspector had a conversation with ABF representative Mr. Kevin Carpenter. Mr. Kevin Carpenter relayed that ZPMC stated that the gaps for all the sections appeared to be in accordance with the contract documents. Note: ZPMC did not mark the allowance according with fitting lines at this time. ZPMC representative relayed that ZPMC was performing a preliminary check.

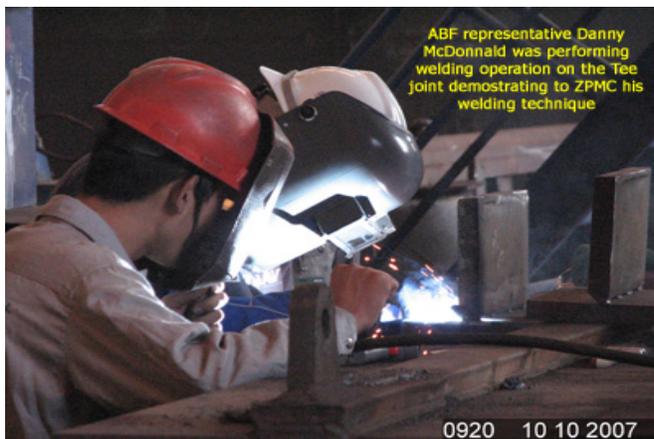
4 ABF welding demonstration

The QA inspector observed ABF representative Danny McDonald performing welding operations on a practice test sample. ABF was doing a demonstration for ZPMC showing Mr. Danny McDonald welding technique at the Tee joint complete joint penetration (CJP) in the horizontal (2G) position. The digital photograph below captures Mr. Danny McDonald performing welding operations on a practice test piece.

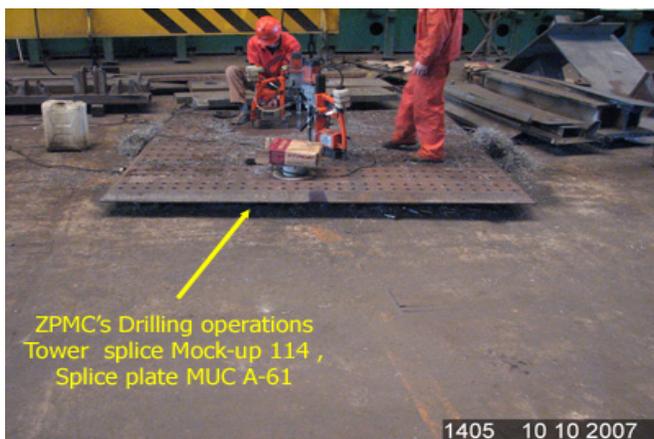
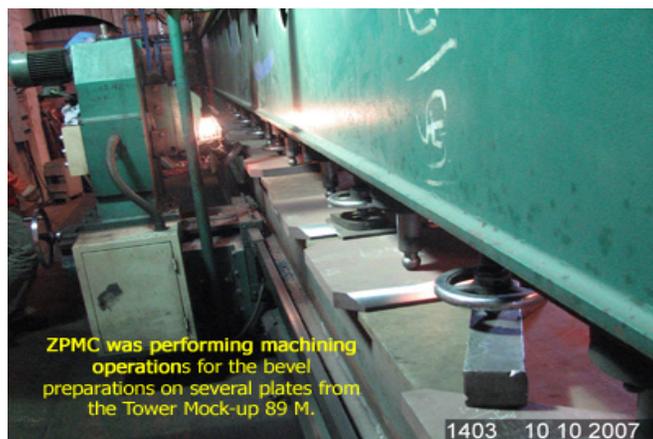
- 5 Drilling and Cutting Tower Mock-up 114 M and 89 M.

The QA inspector observed ZPMC performing machining operations at the bevels for the Tower Mock-up 89 M and performing drilling operations on the Tower splice Mock-up 114 M piece marked MUC-A61.
