Contract #: 04-0120F4Cty: SF/ALA Rte: 80 PM: 13.2/13.9File #: 69.28**WELDING INSPECTION REPORT****Resident Engineer:** Pursell, Gary**Address:** 333 Burma Road**City:** Oakland, CA 94607**Report No:** WIR-000696**Date Inspected:** 11-Oct-2007**Project Name:** SAS Superstructure**OSM Arrival Time:** 630**Prime Contractor:** American Bridge/Fluor Enterprises, a JV**OSM Departure Time:** 1530**Contractor:** Zhenhua Port Machinery Company, Ltd (ZPMC), Changxing Island **Location:** Shanghai, China**CWI Name:** Xu Jun**CWI Present:** Yes No**Inspected CWI report:** Yes No N/A**Rod Oven in Use:** Yes No N/A**Electrode to specification:** Yes No N/A**Weld Procedures Followed:** Yes No N/A**Qualified Welders:** Yes No N/A**Verified Joint Fit-up:** Yes No N/A**Approved Drawings:** Yes No N/A**Approved WPS:** Yes No N/A**Delayed / Cancelled:** Yes No N/A**Bridge No:** 34-0006**Component:** Tower Mock-up 77, 89 and 114 & OBG**Summary of Items Observed:**

CALTRANS Quality Assurance (QA) Inspector, Alfredo Acuna was present for the fabrication of the Mock-up 77, 89 and 114 meters elevations scheduled for this project at the ZPMC facility in Shanghai, China for the San Francisco Oakland Bay Sel

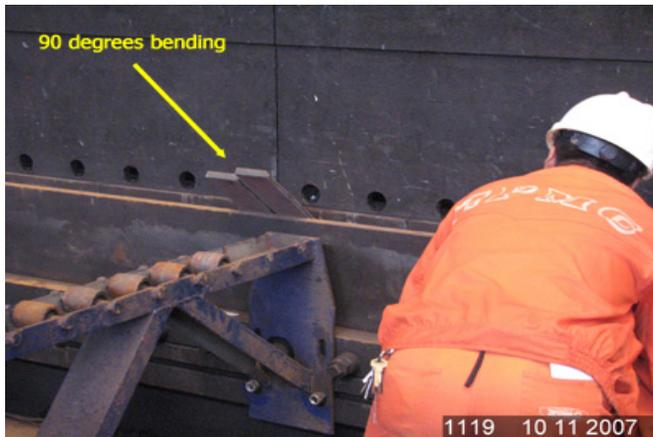
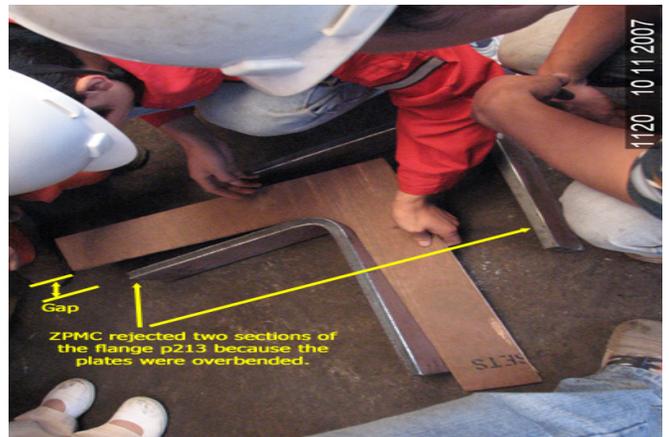
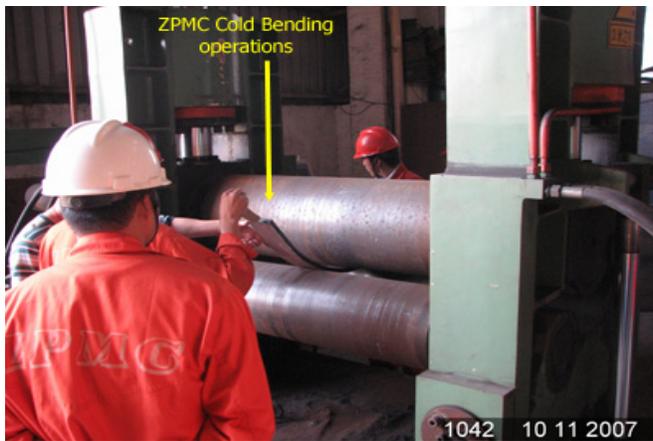
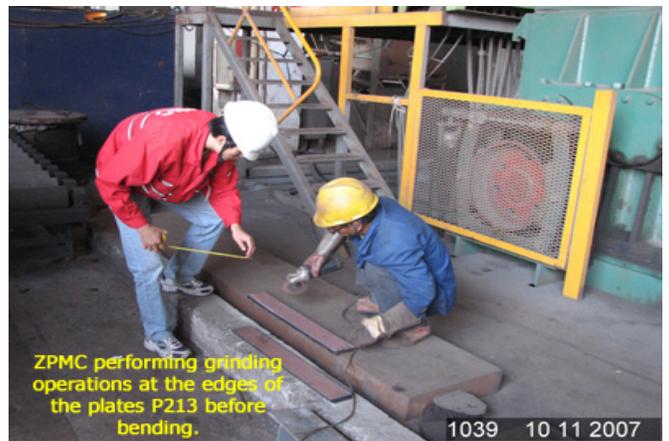
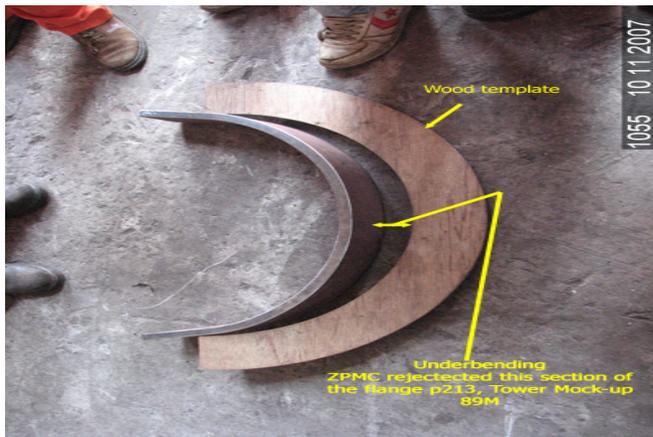
Item	Description	WBS	Dwg No.	Status
4	Cold Bending of the Flange p213 Tower Mock-up 89 Meter Elevation. The QA inspector witnessed the cold bending for the flange p213. This flange would be connected to the diaphragm plate SA-13. Just before the bending start, the QA inspector brought to the attention of the ABF representative Mr. Danny McDonald that the edges of the plates were not ground round 2 mm as per Special Provisions. Mr. McDonald agreed and requested to ZPMC QA representative Hu Gang that the edges needed to be bended as per special provisions. ZPMC ground the edges of the plates and bent the 3 sections of the components of the flange. ZPMC rejected the three sections because under bending and overbending of the plates. The photographs below show the plates when ZPMC was grinding the edges, during bending and when ZPMC was checking dimensions with the templates. The QA inspector performed random dimensional verifications of the plates (three sections P213) and ZPMC's templates before bending, and appeared to be in compliance with the contract documents.

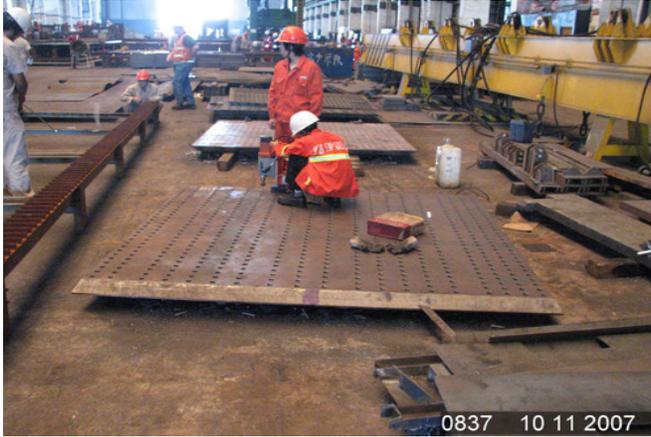
- 5 Drilling and Cutting Tower Mock-up 114 M and 89 M.
The QA inspector observed ZPMC performing machining operations at the bevels for the Tower Mock-up 89 M and performing drilling operations on the Tower splice Mock-up 114 M piece marked MUC-A61.

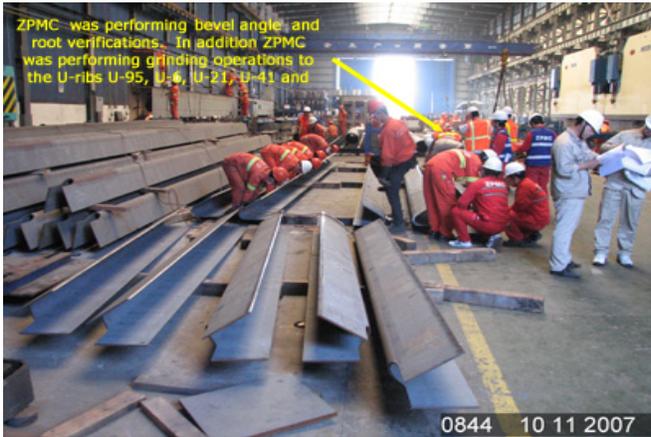
6 OBG Weld Trial U ribs

The QA inspector observed that ZPMC was performing grinding operations at the U ribs U-95, U-6, U-21, U-41 and U-3. The QA inspector performed preliminary random verifications of the bevel angle and the root faces.
