DEPARTMENT OF TRANSPORTATION

Contract #: 04-0120F4Cty: SF/ALA Rte: 80 PM: 13.2/13.9File #: 69.28**WELDING INSPECTION REPORT****Resident Engineer:** Pursell, Gary**Address:** 333 Burma Road**City:** Oakland, CA 94607**Report No:** WIR-000742**Date Inspected:** 30-Oct-2007**Project Name:** SAS Superstructure**OSM Arrival Time:** 630**Prime Contractor:** American Bridge/Fluor Enterprises, a JV**OSM Departure Time:** 1500**Contractor:** Zhenhua Port Machinery Company, Ltd (ZPMC), Changxing Island **Location:** Shanghai, China

Caltrans Quality Assurance (QA) Inspector, Mike Hasler was present to observe the fitup, welding and related activities associated with the fabricating of Caltrans Mock-up, 77M, 89M, 114M and U-Rib Trial Assembly, for the San Francisco Oakland Bay Self Anchored Suspension Bridge, at Zhenhua Port Machinery Company (ZPMC) facility on Changxing Island.

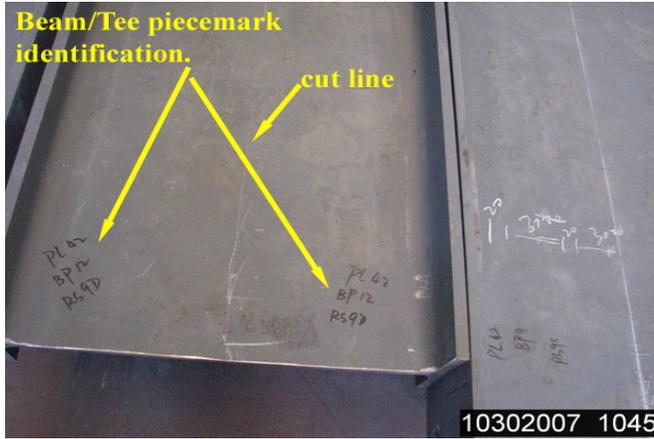
Orthotropic Bridge Girder (OBG) Building #2: Caltrans QA Inspector observed ZPMC oxy-fuel flame cutting diaphragm plates using the computer numerical control (CNC) cutting process at Mockup Shop, building #2. The material is identified as 12mm X 2900mm X 15400mm; piecemark number X14-X14A 1, identification number NG070513G044, batch number 072013730502, material type A709M 345T2-X, and piecemark number X15-X15A 2, identification number NG070513G045, batch number 072013740101, material type A709M 345T2-X. Following digital pictures illustrate material identification and the oxy-fuel flame cutting of the plate in progress.
