DEPARTMENT OF TRANSPORTATION

Contract #: 04-0120F4Cty: SF/ALA Rte: 80 PM: 13.2/13.9File #: 69.28**WELDING INSPECTION REPORT****Resident Engineer:** Pursell, Gary**Address:** 333 Burma Road**City:** Oakland, CA 94607**Report No:** WIR-000744**Date Inspected:** 27-Oct-2007**Project Name:** SAS Superstructure**OSM Arrival Time:** 630**Prime Contractor:** American Bridge/Fluor Enterprises, a JV**OSM Departure Time:** 1500**Contractor:** Zhenhua Port Machinery Company, Ltd (ZPMC), Changxing Island **Location:** Shanghai, China**CWI Name:** Ye Yong Jun & Li Gang**CWI Present:** Yes No**Inspected CWI report:** Yes No N/A**Rod Oven in Use:** Yes No N/A**Electrode to specification:** Yes No N/A**Weld Procedures Followed:** Yes No N/A**Qualified Welders:** Yes No N/A**Verified Joint Fit-up:** Yes No N/A**Approved Drawings:** Yes No N/A**Approved WPS:** Yes No N/A**Delayed / Cancelled:** Yes No N/A**Bridge No:** 34-0006**Component:** Caltrans Mockup**Summary of Items Observed:**

Caltrans Quality Assurance (QA) Inspector, Mike Hasler was present to observe the fit up, welding and related activities associated with the fabricating of Caltrans Mock-up, 77M, 89M, 114M and U-Rib Trial Assembly,

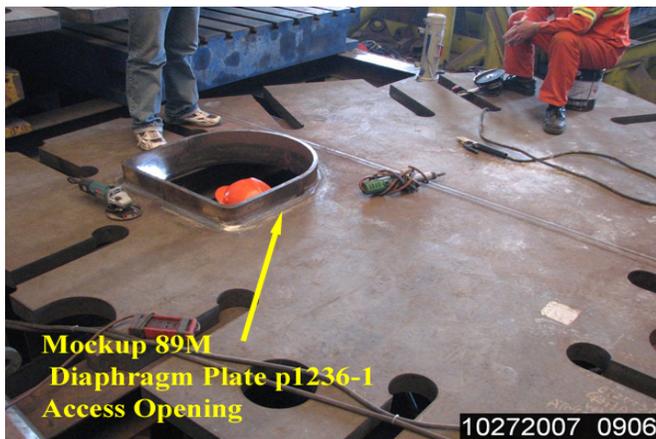
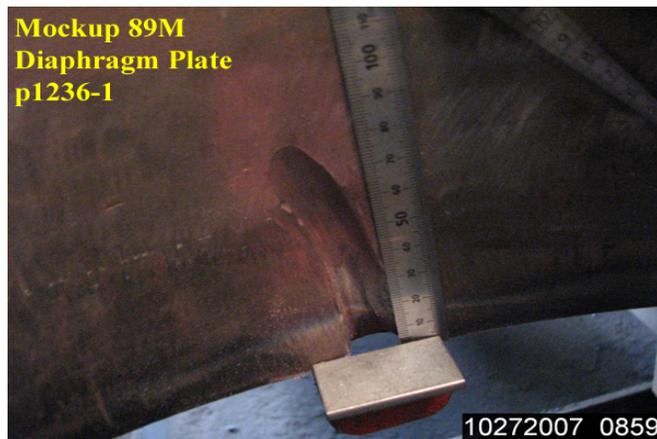
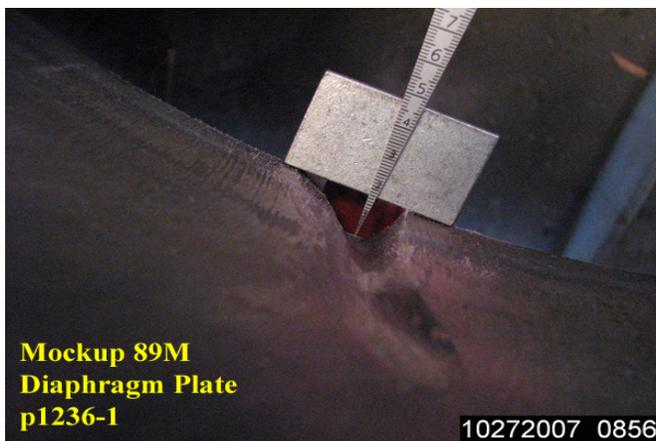
2	Diaphragm Plate Mock-Up 89M, SA13 (p1236-1) Diaphragm Plate: ZPMC QC Inspector, Mr. Fu Yu hong informed Caltrans QA Inspector that ZPMC would be performing magnetic particle testing (MT) in the tower shop. Caltrans QA Inspector witnessed ZPMC QC, Mr. Cai Xin Xin perform MT inspection at access opening ring, partial joint penetration (PJP) weld joining ring to the diaphragm plate. Caltrans QA Inspector observed that the area to be MT appeared to have an area on the plate that had something removed by grinding. This ground area started at the plate edge and transverse	NA	NA	Pending Caltrans Approval

the PJP weld. The length and depth of the material removal area measured 11 to 6 mm deep and 80mm in length. Caltrans QA Inspector asked Mr. Fu Yu hong if he had a Caltrans engineering approval to perform welding repair of the material excavation area. Mr. Fu Yu hong stated that no one informed him that a Caltrans approval was needed. Mr. Fu canceled the MT inspection and stated that ZPMC would notify ABF of this weld repair, pending ABF resolution. Following pictures illustrate location requiring repair welding at the access opening ring.

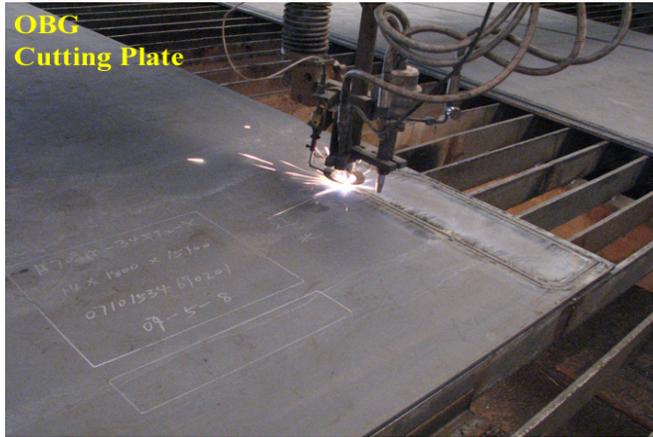
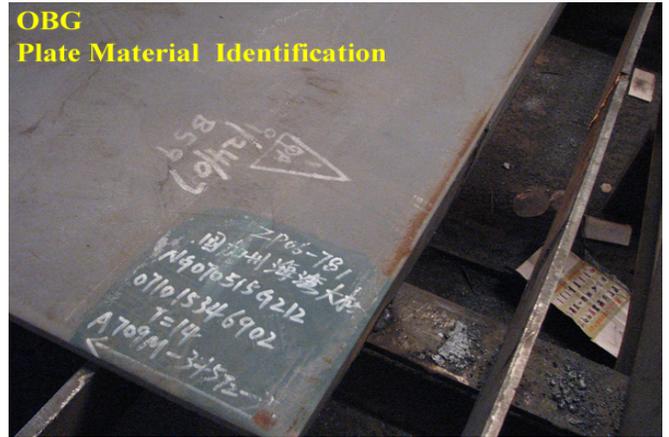
| Caltrans QA Inspector observed ZPMC oxy-fuel flame cutting plate nesting at Mockup Shop #2, burn table. The plate nesting consisted of small parts identified as X3-X3N (80 pieces), X3-X3L (80 pieces), X3-X3M (80 pieces), and X3-X3K (132 pieces). The plate was identified as A709M-345T2-X, 14mm X 1800mm X 15100mm, plate batch | | | | |

number 071015346902. Following digital pictures illustrates plate material identification and oxy-fuel flame cutting in progress.
