**DEPARTMENT OF TRANSPORTATION**

Contract #: 04-0120F4Cty: SF/ALA Rte: 80 PM: 13.2/13.9File #: 69.28**WELDING INSPECTION REPORT****Resident Engineer:** Pursell, Gary**Address:** 333 Burma Road**City:** Oakland, CA 94607**Report No:** WIR-004030**Date Inspected:** 30-Aug-2008**Project Name:** SAS Superstructure**OSM Arrival Time:** 1400**Prime Contractor:** American Bridge/Fluor Enterprises, a JV**OSM Departure Time:** 2300**Contractor:** Zhenhua Port Machinery Company, Ltd (ZPMC), Changxing Island **Location:** Shanghai China

Tower Shop Bay 3 Deck Panel repairs

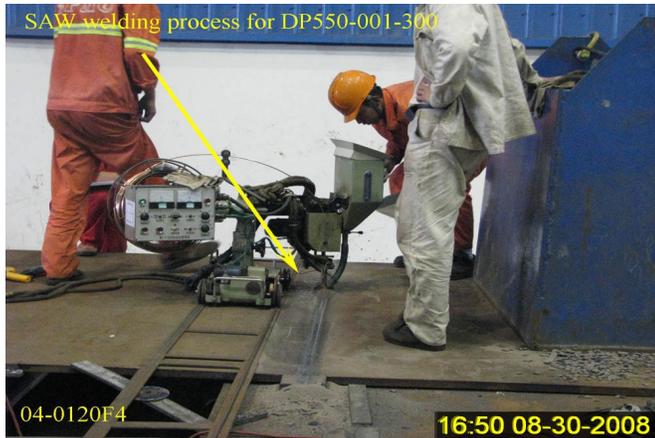
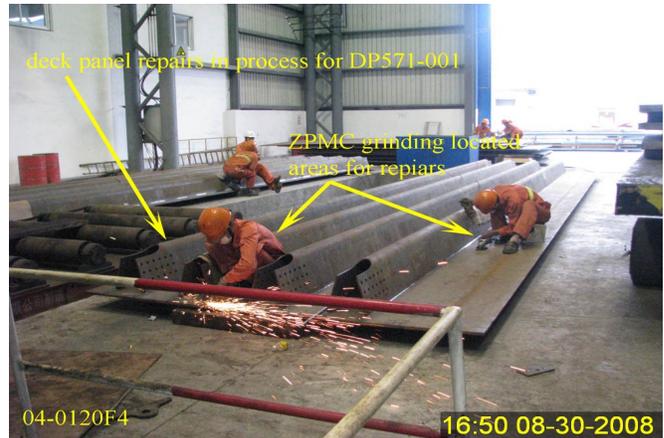
The QA Inspector randomly observed ZPMC personnel performing grinding of repairs for the Orthotropic Box Girder (OBG) deck panel Partial Joint Penetration (PJP) welds. During initial observations it was noted that fourteen (14 ea) deck panels are inside the shop. This QA inspector observed ZPMC performing repair's on the following deck panels; DP596-001, DP546-002 and DP571-001 these were in process for the remainder of this shift. This QA inspector along with ZPMC and ABF performed the 3 party initial visual inspections on DP572-001 and DP552-001 all parties agreed on the locations for repair. Also noted that ZPMC had six (6) Deck Panel plates located in bay 3 performing CJP weld splicing using the SAW process on DP550-001-300 and DP605-001-300 were being welded at the time of QA's observations. The remaining panels were idle except for DP615-001-300 and DP545-001-300 which had been back gouged and was waiting to receive the SAW welding process for completion. Certified Welding Inspector for ZPMC Sun Bo was present at this location for the monitoring of the deck repairs and inspection. Also noted in bay 3 to monitor deck panel repairs were ABF personnel Wang Zhong Yuan and Ding Bao Hua.
