Contract #: 04-0120F4Cty: SF/ALA Rte: 80 PM: 13.2/13.9File #: 69.28**WELDING INSPECTION REPORT****Resident Engineer:** Pursell, Gary**Address:** 333 Burma Road**City:** Oakland, CA 94607**Report No:** WIR-004057**Date Inspected:** 12-Sep-2008**Project Name:** SAS Superstructure**OSM Arrival Time:** 1330**Prime Contractor:** American Bridge/Fluor Enterprises, a JV**OSM Departure Time:** 2230**Contractor:** Zhenhua Port Machinery Company, Ltd (ZPMC), Changxing Island **Location:** Shanghai, China

Bridge No: 34-0006**Component:** OBG Fabrication**Summary of Items Observed:**

Assembly bay 1:

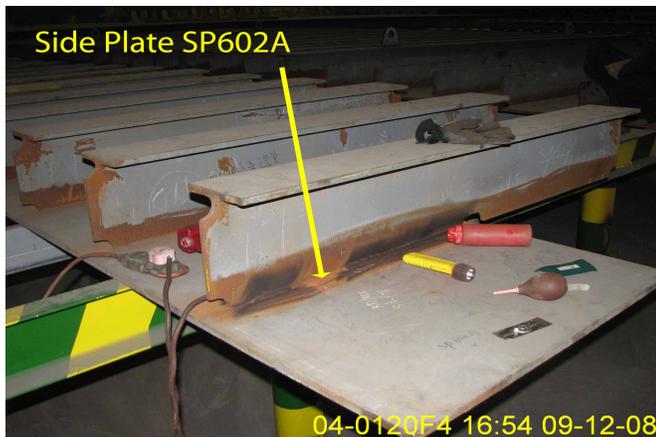
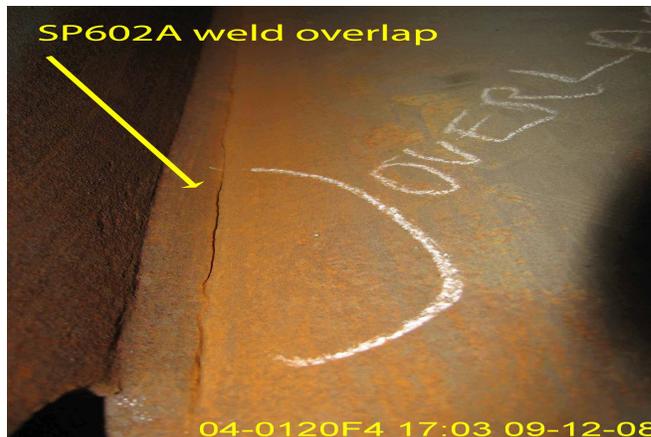
ABF representative Mr. Kevin Dye had informed QA that SP602A / 5BE is ready for QA green tagging. ZPMC QC has previously visually accepted these welds. ZPMC workers removed the rust from two of the welds to allow the QA Inspector to perform magnetic particle inspections of the welds. The QA Inspector performed random visual inspections of various welds on SP602A and observed some of the welds have undercut and overlap. The QA Inspector showed ZPMC representative Mr. Lei Tau the visually rejectable welds and Mr. Tau said the welds will be repaired. See the photographs below for additional information.
