Contract #: 04-0120F4Cty: SF/ALA Rte: 80 PM: 13.2/13.9File #: 69.28**WELDING INSPECTION REPORT****Resident Engineer:** Pursell, Gary**Address:** 333 Burma Road**City:** Oakland, CA 94607**Report No:** WIR-004128**Date Inspected:** 01-Oct-2008**Project Name:** SAS Superstructure**OSM Arrival Time:** 1800**Prime Contractor:** American Bridge/Fluor Enterprises, a JV**OSM Departure Time:** 630**Contractor:** Zhenhua Port Machinery Company, Ltd (ZPMC), Changxing Island **Location:** Shanghai, China**CWI Name:****CWI Present:**

Bridge No: 34-0006**Component:** OBG Deck Panel**Summary of Items Observed:**

Assembly Building: Caltrans Quality Assurance (QA) inspector received notification from 2nd shift Task Leader to perform conventional ultrasonic test (UT), gate to gate inspection of tack welds joining u-rib to deck plate. The deck panel is identified as DP324-002. The UT inspection performed by the Caltrans QA inspector was preliminary UT inspection prior to using the phased array UT system to verify indications found by the conventional ultrasonic test. Caltrans QA inspector inspected deck panel DP324-002, welds 001, 002, 003, 004, 006, 007 and 008. With each weld consisted of twenty

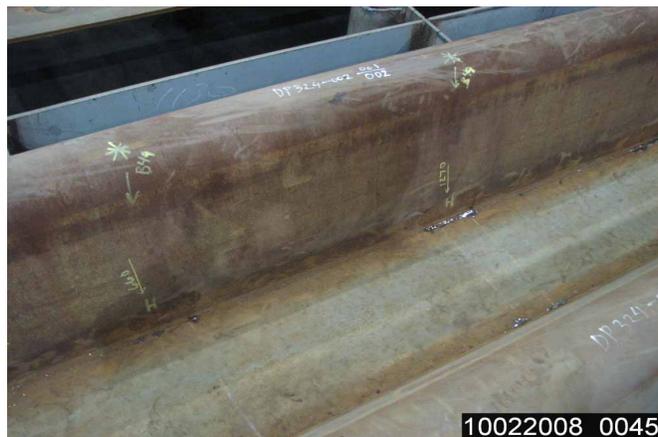
Weld 002; Observed weld indication at Y-location, 660, 1270, 4900, and 8500 millimeter mark.

Caltrans QA inspectors, Larry Viars and Erik Prue assisted in the UT inspection of deck panel DP324-002. See Caltrans U-rib to Deck Panel-Tack Weld Assessment Record, dated 10-01-2008 for additional information. The following digital picture illustrates DP324-001 and Y-locations at weld 002 .
