Contract #: 04-0120F4Cty: SF/ALA Rte: 80 PM: 13.2/13.9File #: 69.28**WELDING INSPECTION REPORT****Resident Engineer:** Pursell, Gary**Address:** 333 Burma Road**City:** Oakland, CA 94607**Report No:** WIR-004142**Date Inspected:** 01-Sep-2008**Project Name:** SAS Superstructure**OSM Arrival Time:** 700**Prime Contractor:** American Bridge/Fluor Enterprises, a JV**OSM Departure Time:** 1730**Contractor:** Zhenhua Port Machinery Company, Ltd (ZPMC), Changxing Island **Location:** Shanghai, China**CWI Name:** CK Chan / Jeff Chen**CWI Present:** Yes No**Inspected CWI report:** Yes No N/A**Rod Oven in Use:** Yes No N/A**Electrode to specification:** Yes No N/A**Weld Procedures Followed:** Yes No N/A**Qualified Welders:** Yes No N/A**Verified Joint Fit-up:** Yes No N/A**Approved Drawings:** Yes No N/A**Approved WPS:** Yes No N/A**Delayed / Cancelled:** Yes No N/A**Bridge No:** 34-0006**Component:** Tower**Summary of Items Observed:**

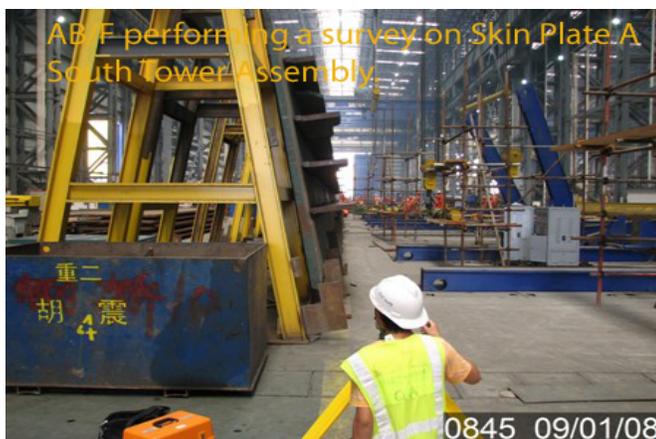
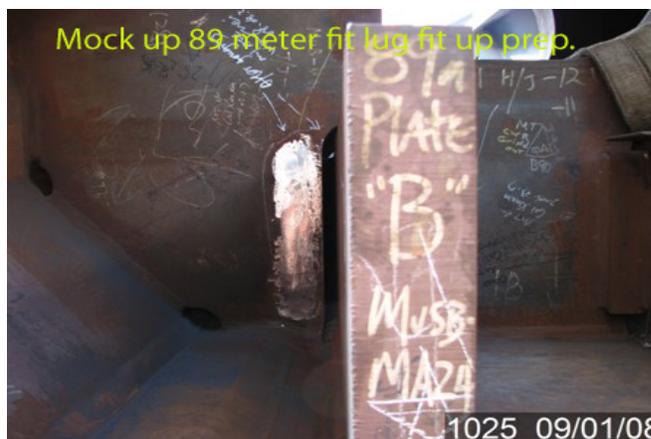
The Quality Assurance Inspector observed ZMPC personnel perform fit up preparations on the 89 meter mock up.
