DEPARTMENT OF TRANSPORTATION

Contract #: 04-0120F4Cty: SF/ALA Rte: 80 PM: 13.2/13.9File #: 69.28**WELDING INSPECTION REPORT****Resident Engineer:** Pursell, Gary**Address:** 333 Burma Road**City:** Oakland, CA 94607**Report No:** WIR-004170**Date Inspected:** 13-Sep-2008**Project Name:** SAS Superstructure**OSM Arrival Time:** 700**Prime Contractor:** American Bridge/Fluor Enterprises, a JV**OSM Departure Time:** 1700**Contractor:** Zhenhua Port Machinery Company, Ltd (ZPMC), Changxing Island **Location:** Shanghai, China**CWI Name:** Sun Wei**CWI Present:** Yes No**Inspected CWI report:** Yes No N/A**Rod Oven in Use:** Yes No N/A**Electrode to specification:** Yes No N/A**Weld Procedures Followed:** Yes No N/A**Qualified Welders:** Yes No N/A**Verified Joint Fit-up:** Yes No N/A**Approved Drawings:** Yes No N/A**Approved WPS:** Yes No N/A**Delayed / Cancelled:** Yes No N/A**Bridge No:** 34-0006**Component:** OBG**Summary of Items Observed:**

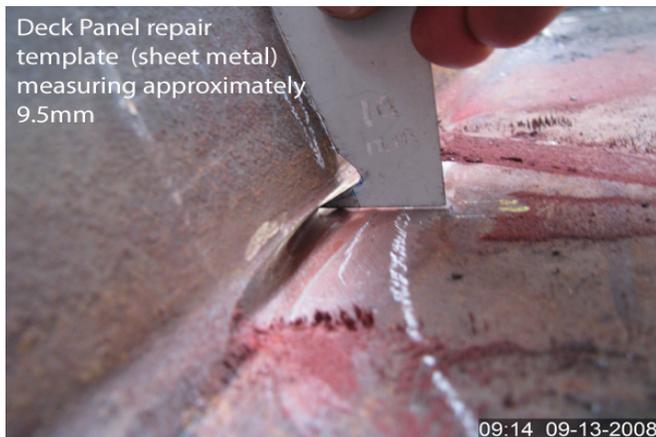
1. Excavate the crack using 100 and or 75 millimeter grinders.
2. Assure 80 percent depth of excavation was achieved by measuring with a sheet metal template. Below is a digital photograph illustrating the template.
3. Perform magnetic particle testing to the excavation. Numerous indications were present at this point.
4. Preheat to a minimum of 110 degrees Celsius.
5. Weld the root pass utilizing the flux cored arc welding process.
6. Grind the root pass and blend with adjacent welds.
7. Perform magnetic particle testing again.
8. Weld the rest of the excavation utilizing the flux cored arc welding process. It was observed this typically takes three to four weld passes.

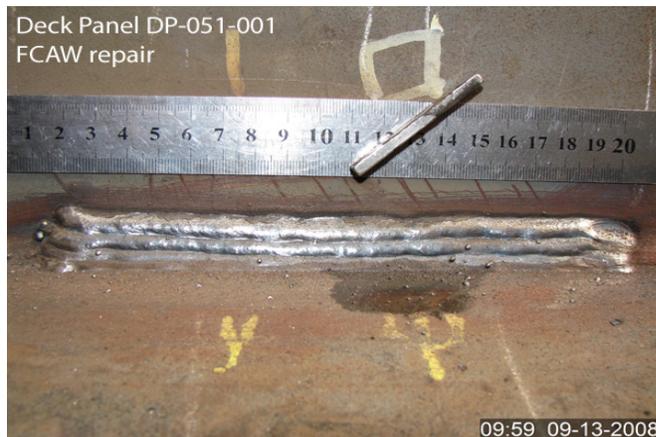
After the first repair flux cored arc welding pass, no crack like indications were observed by ZPMC or the Quality Assurance Inspector. Numerous indications were located by ZPMC and the Quality Assurance Inspector after the initial excavation as illustrated in the digital photograph below. The "Y" axis locations were recorded in an onsite

log for future review.
